CONSTRUCTED LAKES IN THE PERTH METROPOLITAN AREA AND SOUTH WEST REGION

LITERATURE REVIEW AND INTERVIEW PROJECT

Prepared by:	<i>Bronwyn Woodward</i>
Status:	<i>FINAL</i>
QA Review:	<i>Mike Brewis and Paula Austen</i>
Technical Review:	<i>Margaret Dunlop and Karen Lane</i>
Content Review:	<i>Margaret Dunlop and Karen Lane</i>
Date:	<i>6 November 2008</i>

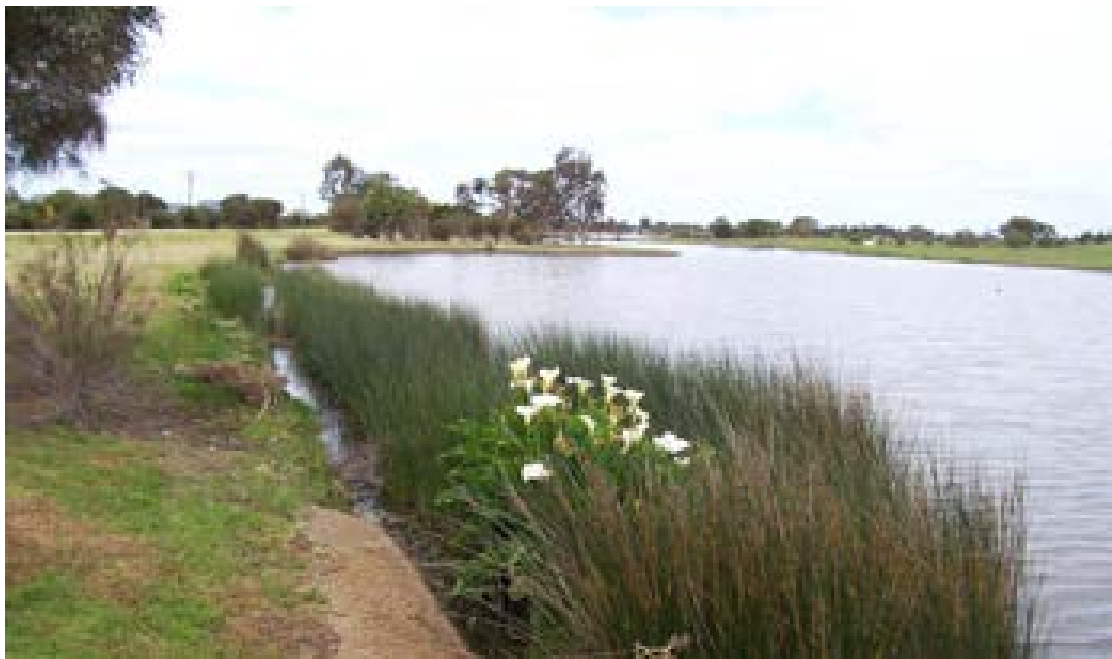
PLATE 2– The exotic Arum lily was observed growing amongst reeds in the lake. This invasive plant is common in wetlands of the south west of Western Australia however the lake manager did not highlight it as a problem in the lake.

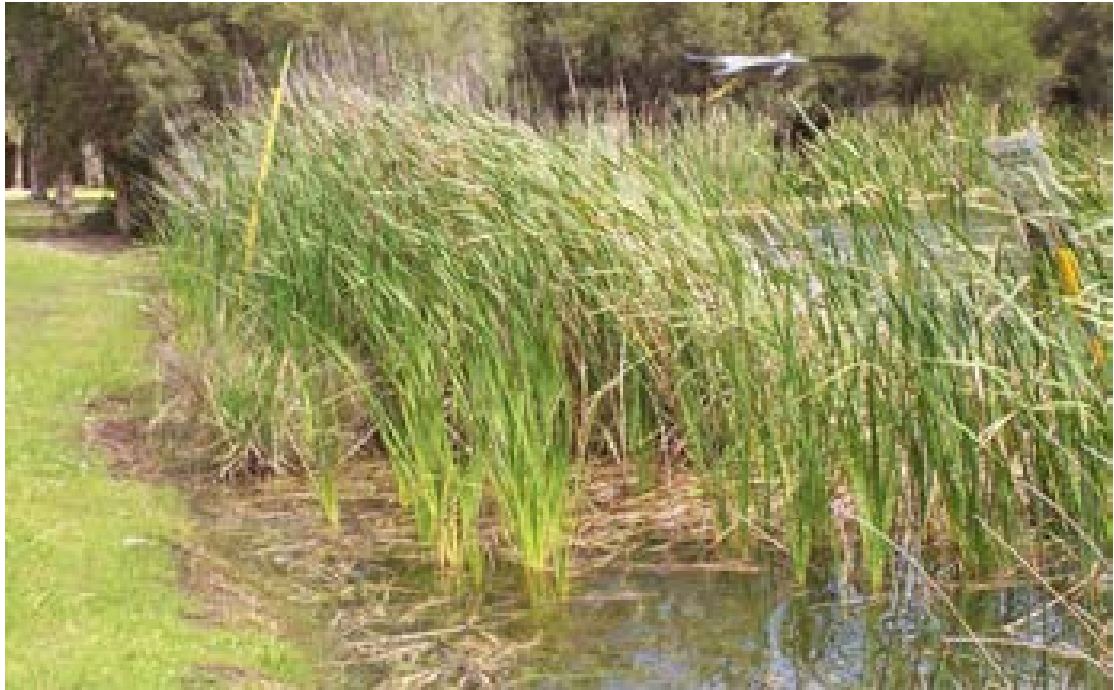
PLATE 3– The aesthetic and habitat value of the lakes has been compromised by problems such as invasion by *Typha* and algal blooms in the irrigation lake to the north of Lake Bungana.

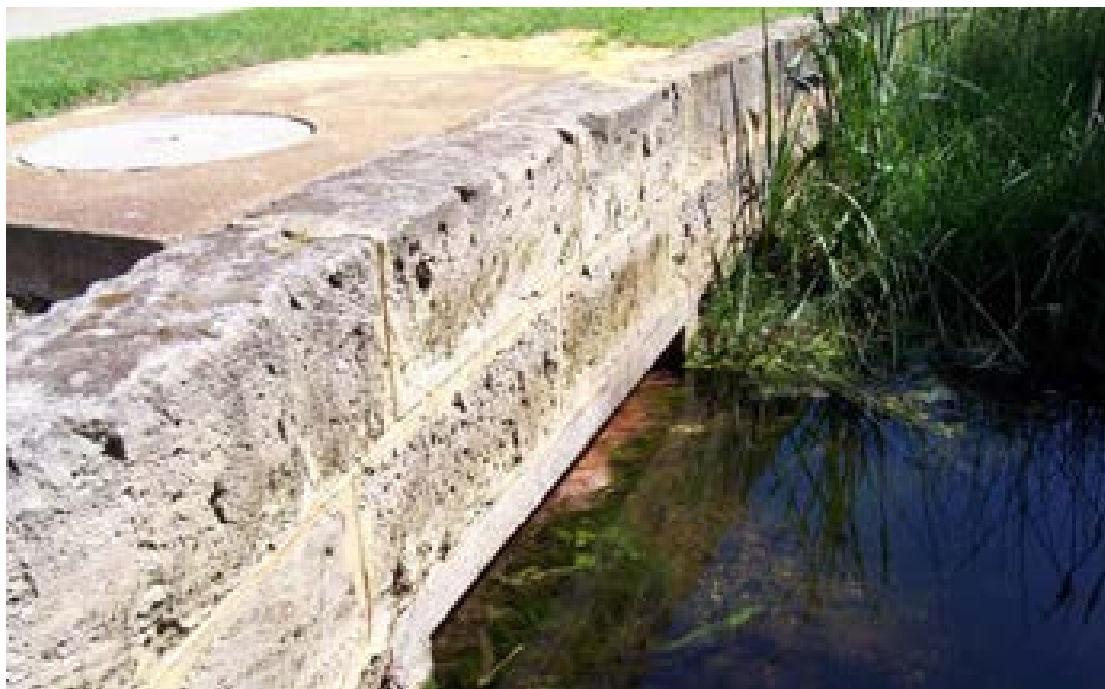
PLATE 2 – Decay of limestone walls at one of the lake inlets.

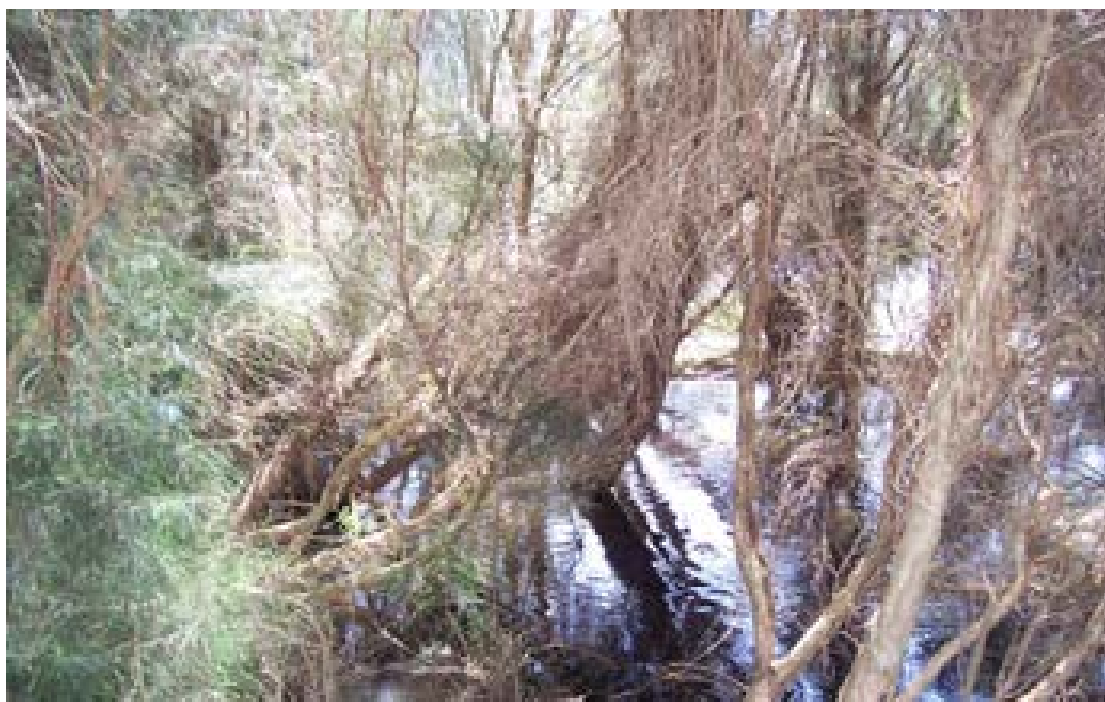
PLATE 3 – Vegetated swale. Water has broken the swales in places therefore flows directly into the lake rather than through the swale.

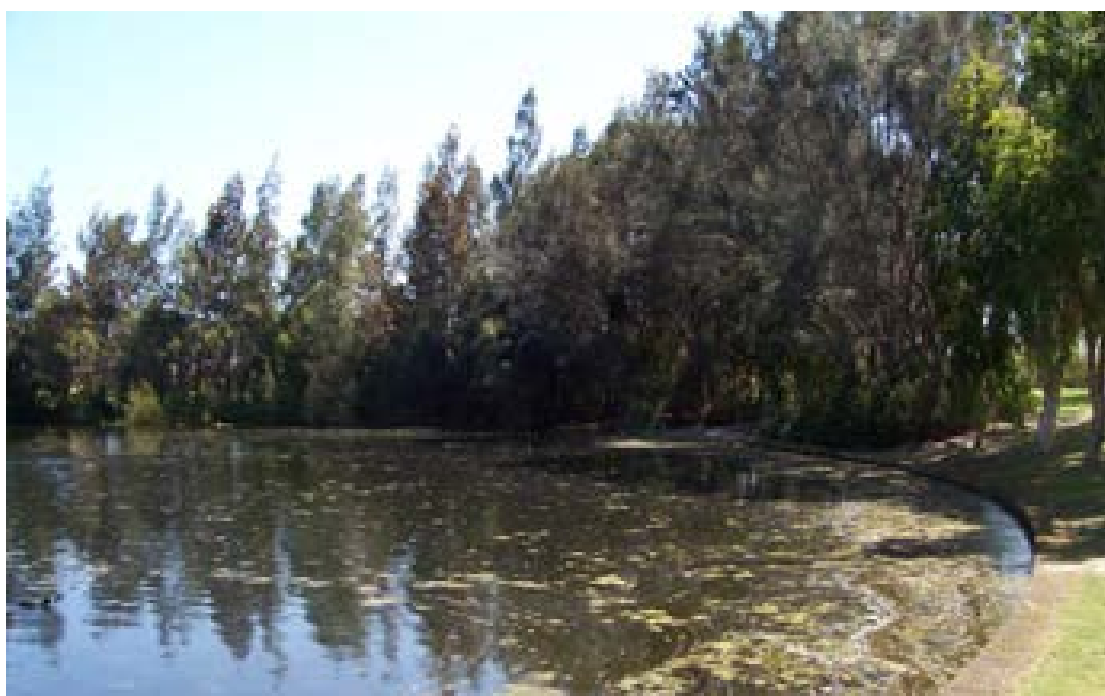
PLATE 4 – Bloom of filamentous green algae in the lake in October 2007.

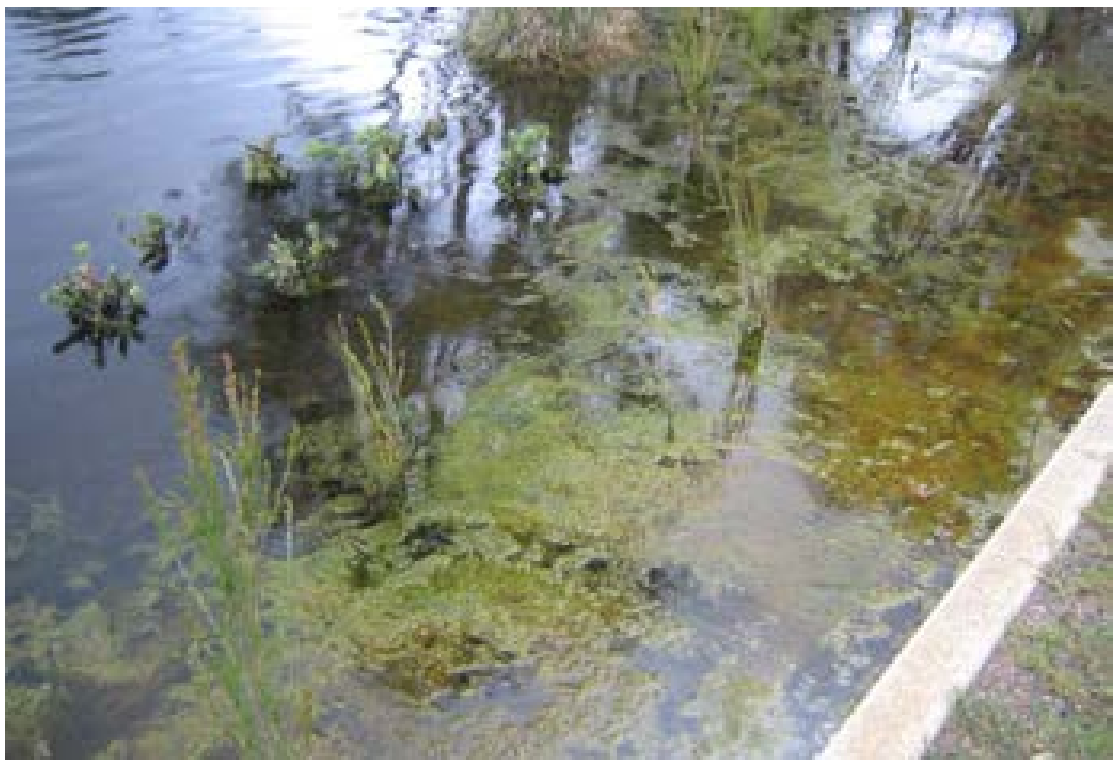
PLATE 2 – High nutrient loads have caused excessive algal growth and midge problems in the Prior Close Reserve Lake.

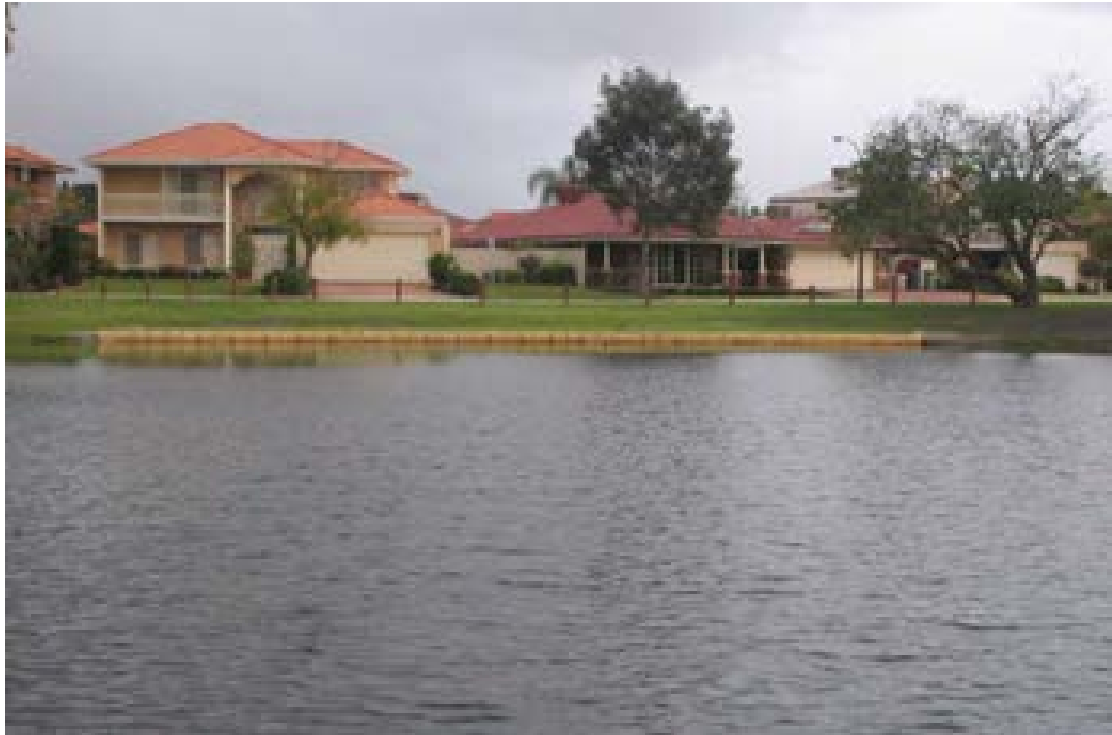
PLATE 3 – The City of Gosnells has constructed hard vertical edges around the Prior Close Reserve Lake to discourage midge breeding and prevent complaints from surrounding residents.

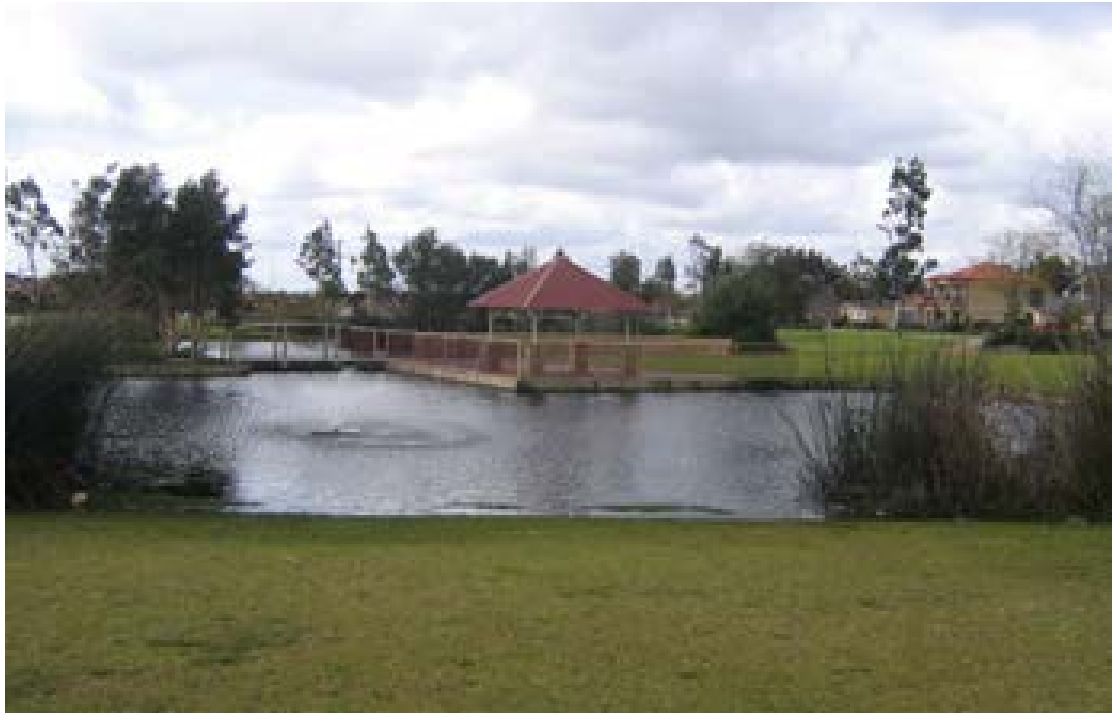
PLATE 1 – The water was relatively clear and no algae was observed during the site visit in September 2007, however the lake has experienced problems with blooms of filamentous green algae in the past.

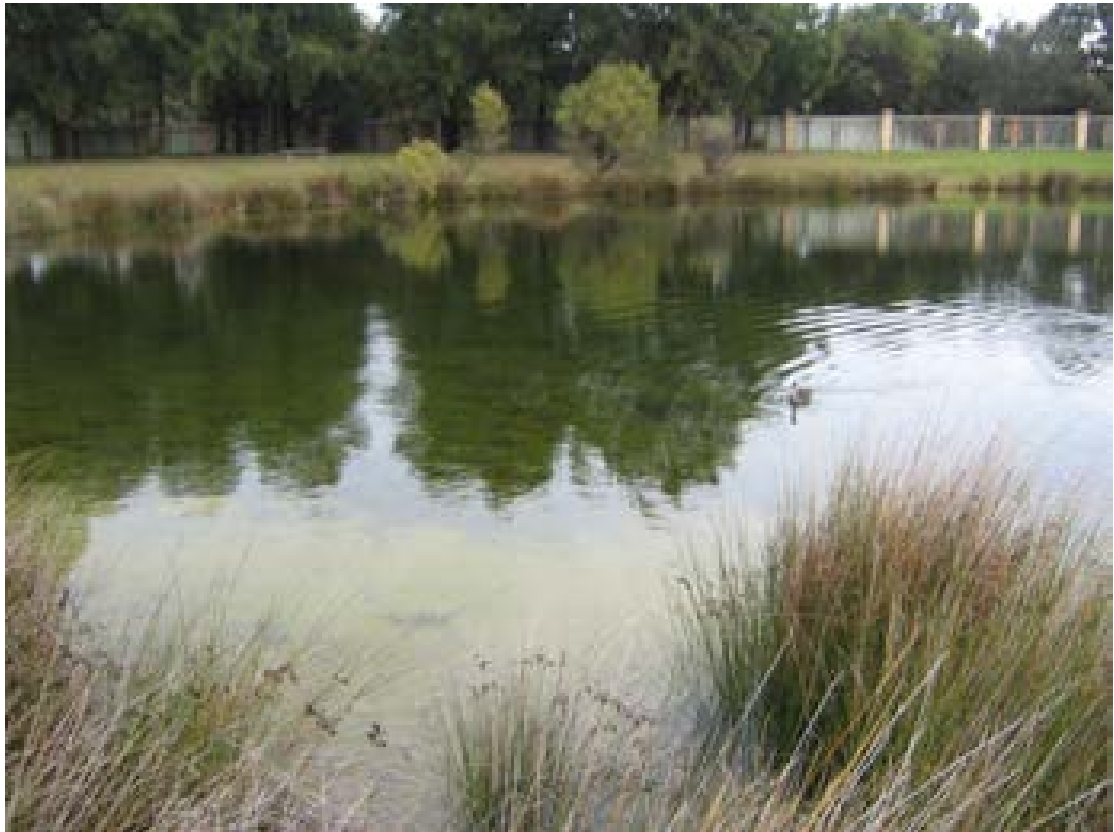
PLATE 1 – Macroalgal bloom visible on bed of Northern Lake.

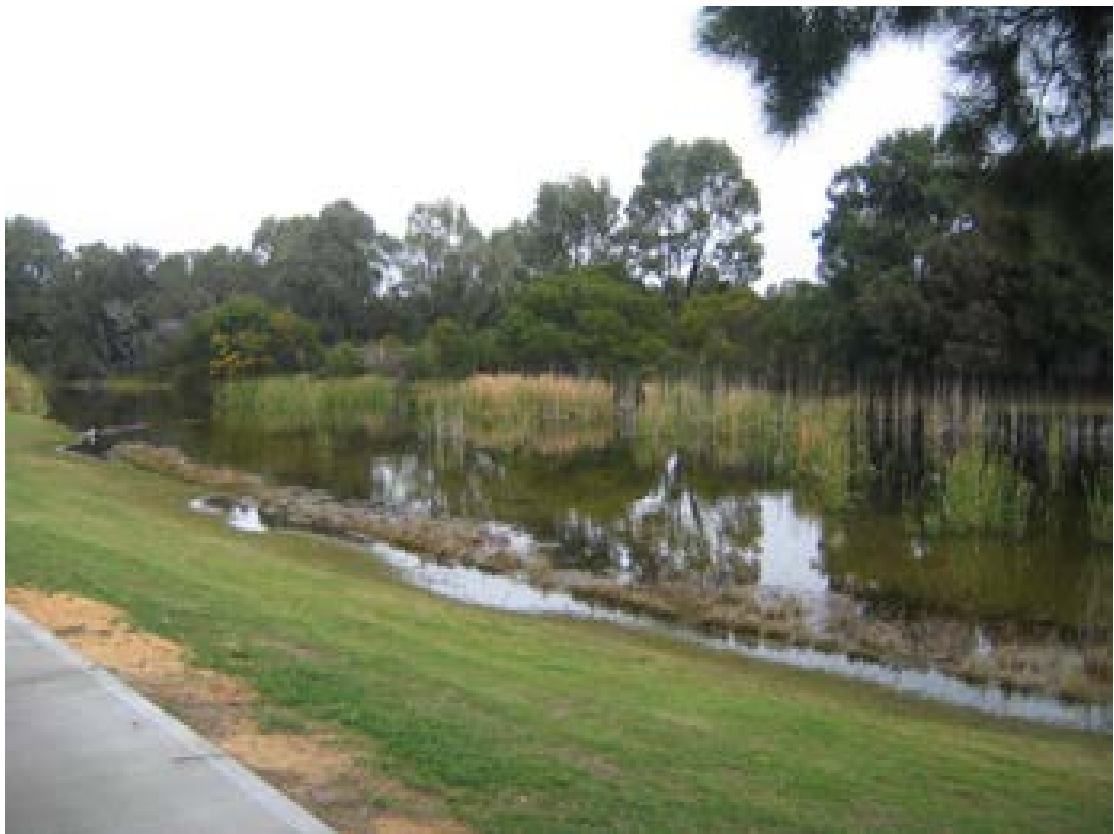
PLATE 2 – *Typha* in Southern Lake.

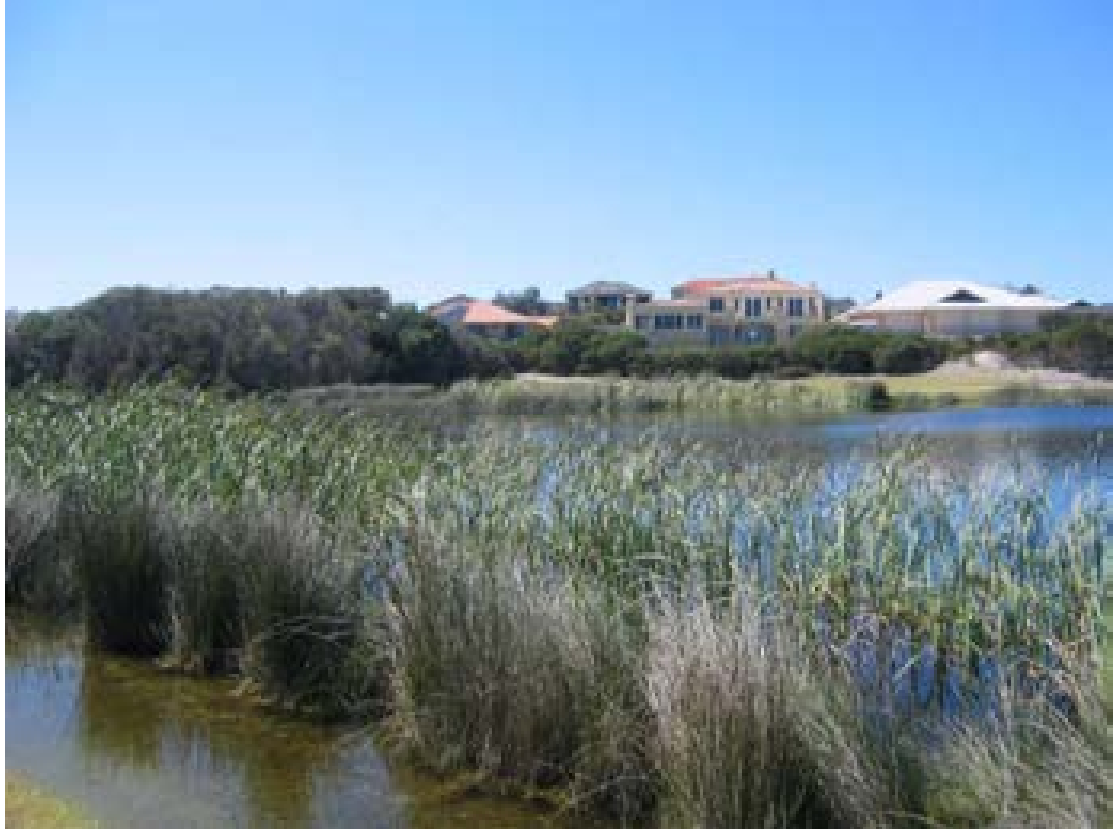
PLATE 1 – *Typha* growing amongst fringing reeds. Residential housing overlooks the lake.

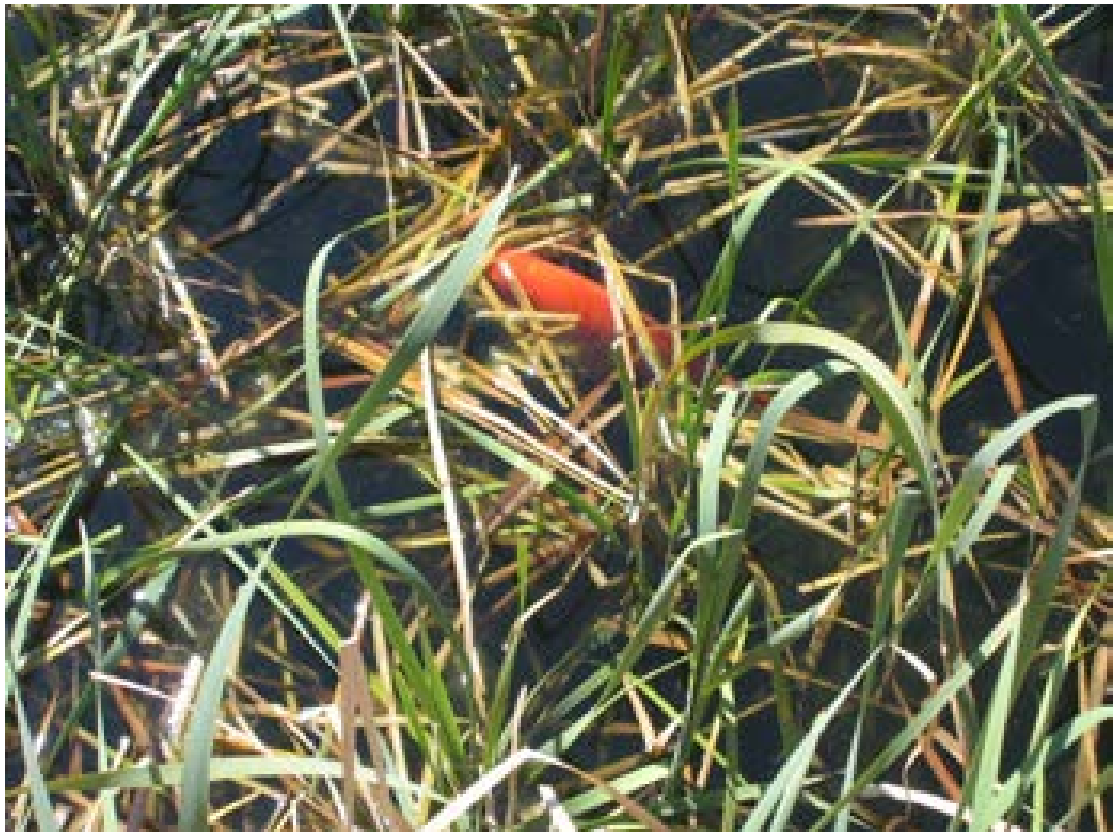
PLATE 2 – Koi Carp in Hidden Swamp.

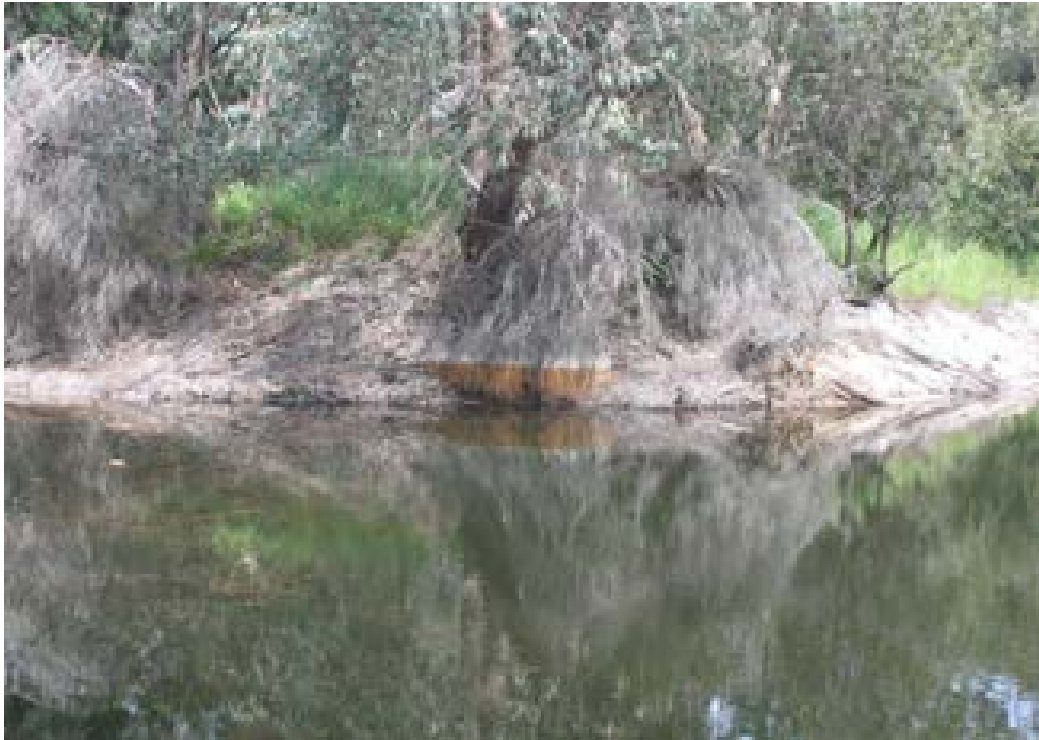
PLATE 1 – Dead vegetation and iron staining related to acidity in the lakes.

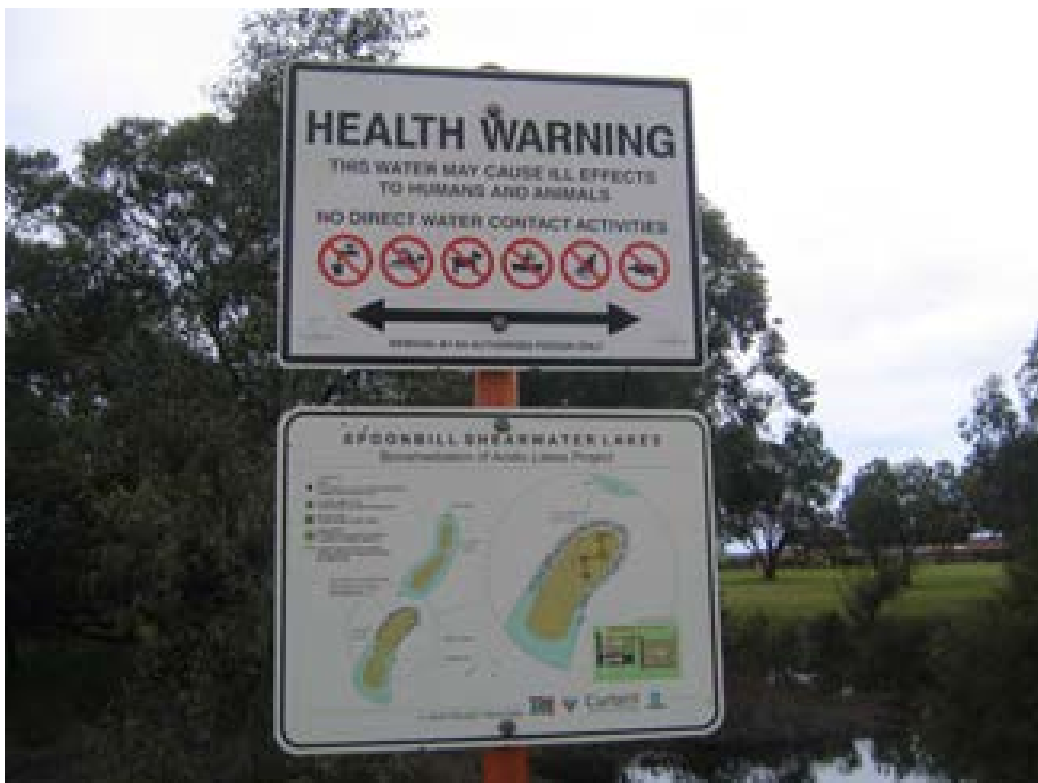
PLATE 2– Health warning signs and a diagram of the bioremediation project informs the public of the lakes' acidity problems.

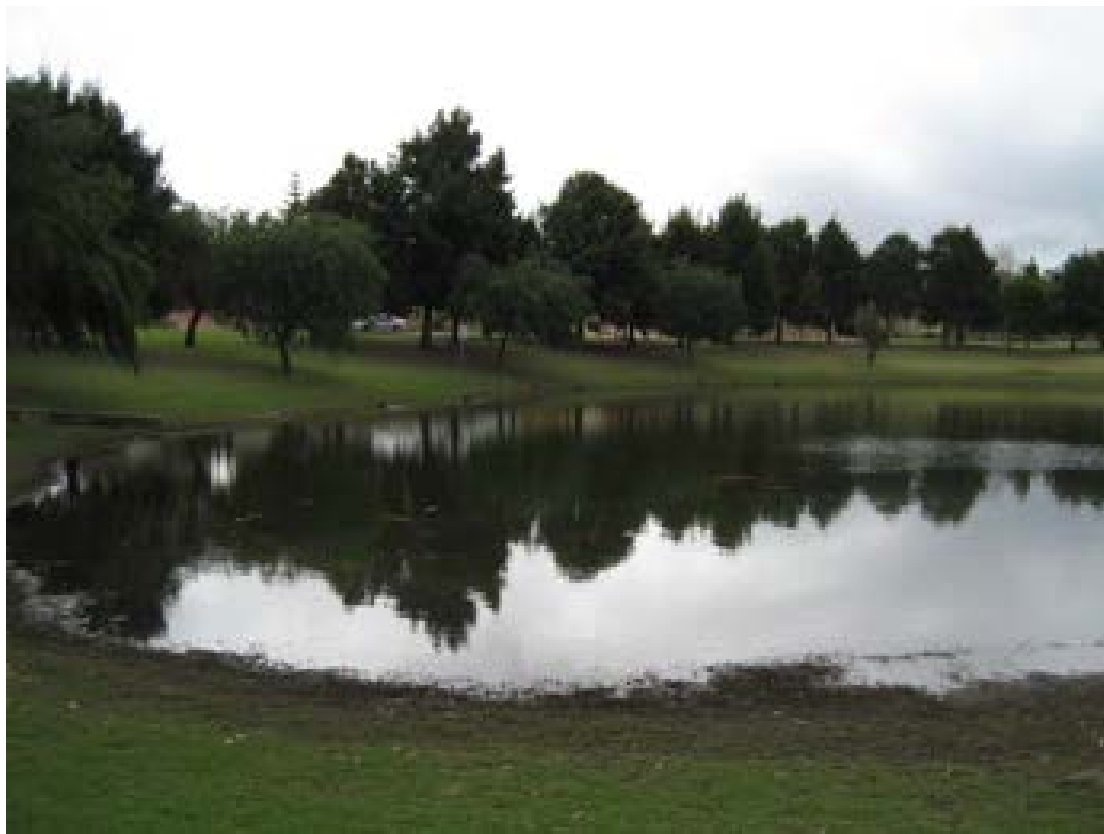
PLATE 1 – Southern side of lake. The turf is damaged due to high water levels.

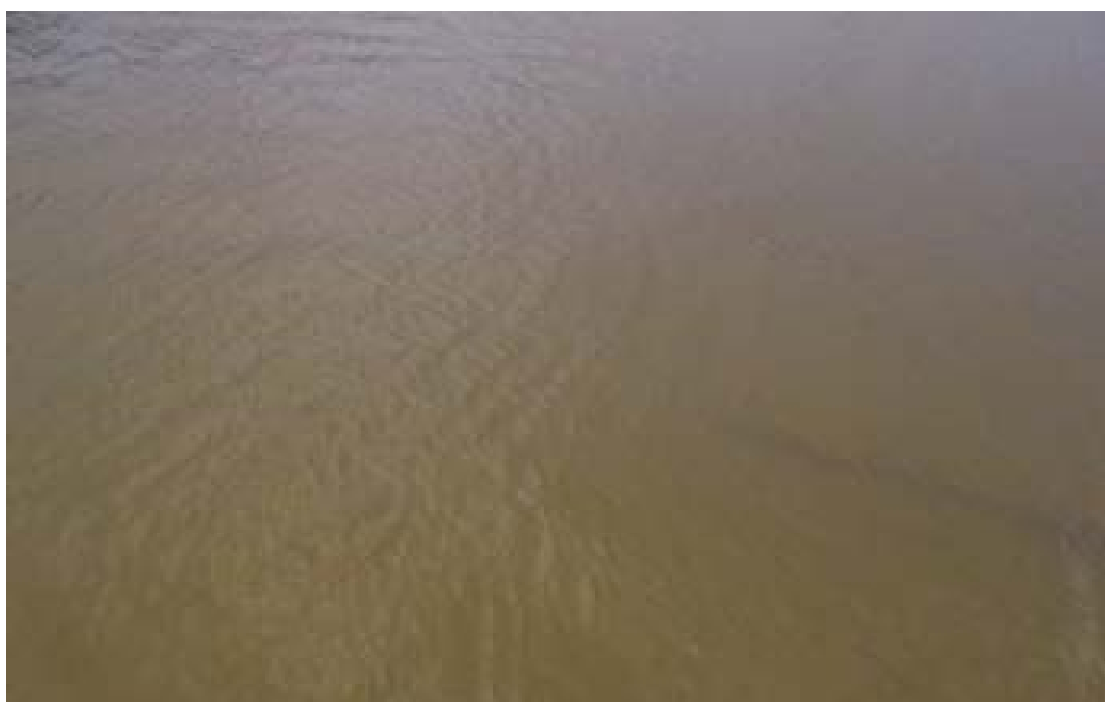
PLATE 4 – Greenish brown water observed in the lake in October 2007.
