# City of Cockburn

## Yangebup Lake Nutrient Stripping Trial

**Aim:** To address excess nutrients in Yangebup Lake by using solar power to pump nutrient rich water from the lake through a treatment train then allowing the treated water to flow back into the lake.

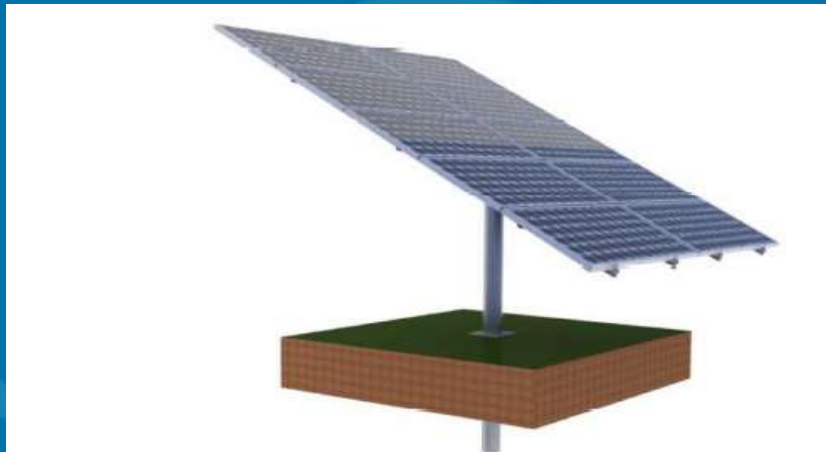
Additional vegetation to strip nutrients,  
provide shade and habitat & vegetation  
provides barrier for midge.

Solar pump to take water from lake minimal  
ongoing cost.

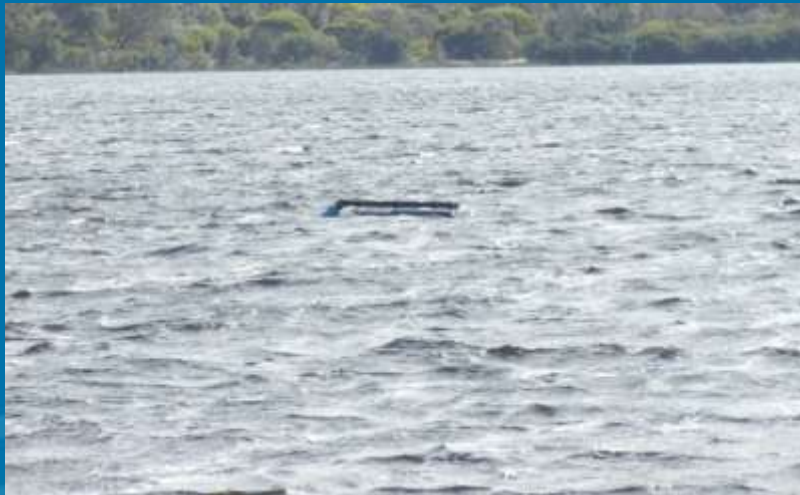
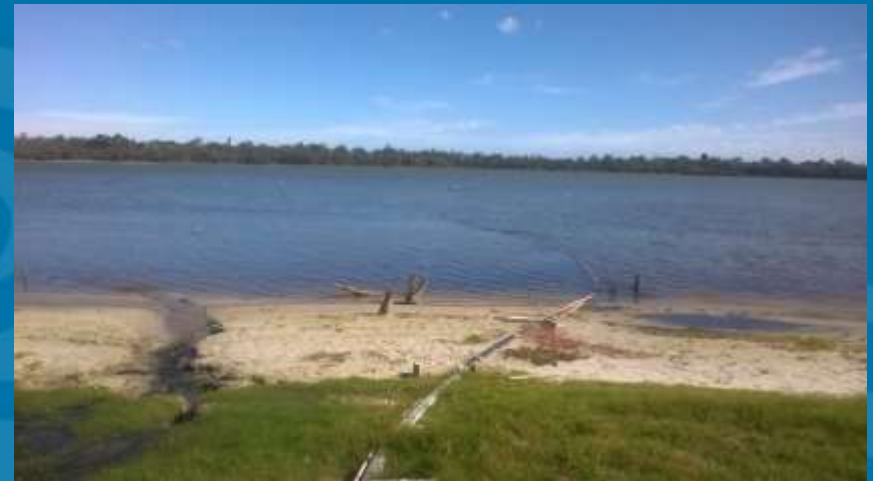
# Nutrient Stripping Basin Pump

- Peak Capacity 200L/m
- 150mm pipe at inlet
- 300mm pipe at outlet into basin
- Pump located on pontoon 80m from shore

- Very Strong Growth (including weeds) - Nutrients possibly in soil or groundwater.
- Floating pump – moving closer to shore due to wind and wave action.
- Pipes floating and visible – potential for vandalism
- Pump stopped pumping due to clogging.

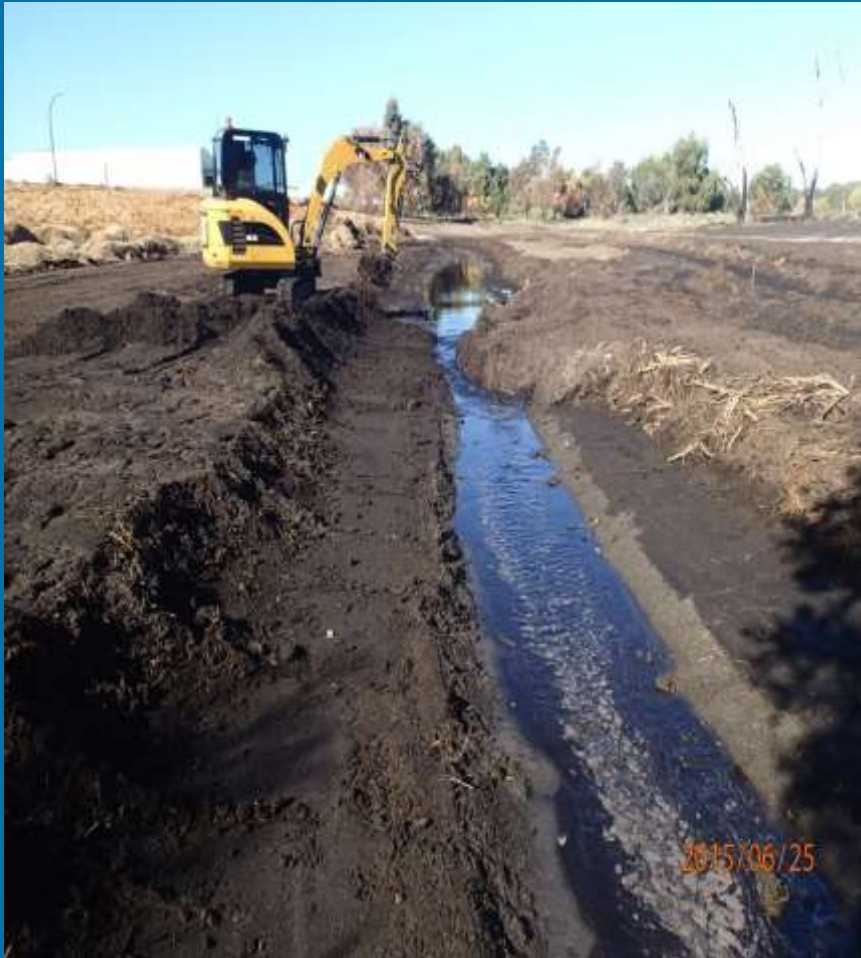
Excavation

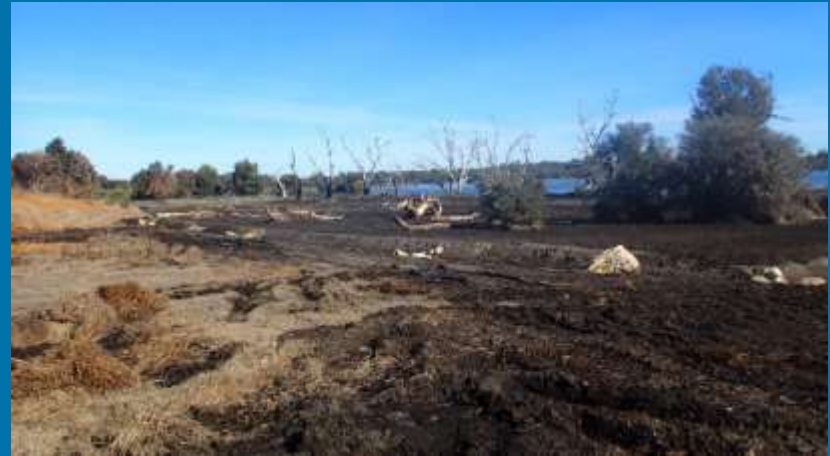
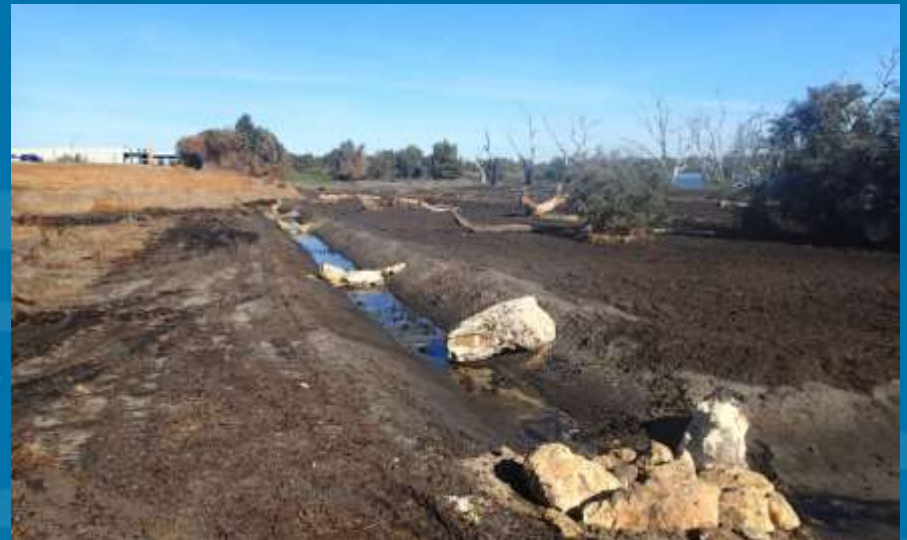
Riffles

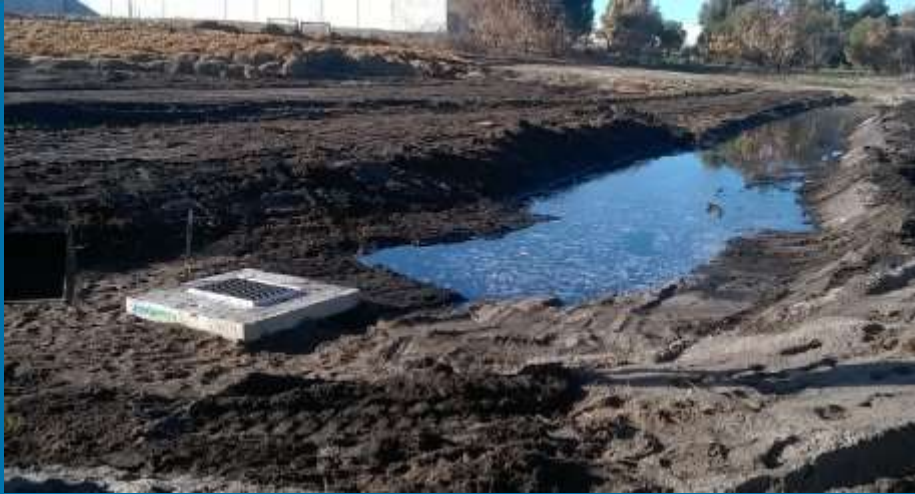
Outlet grate

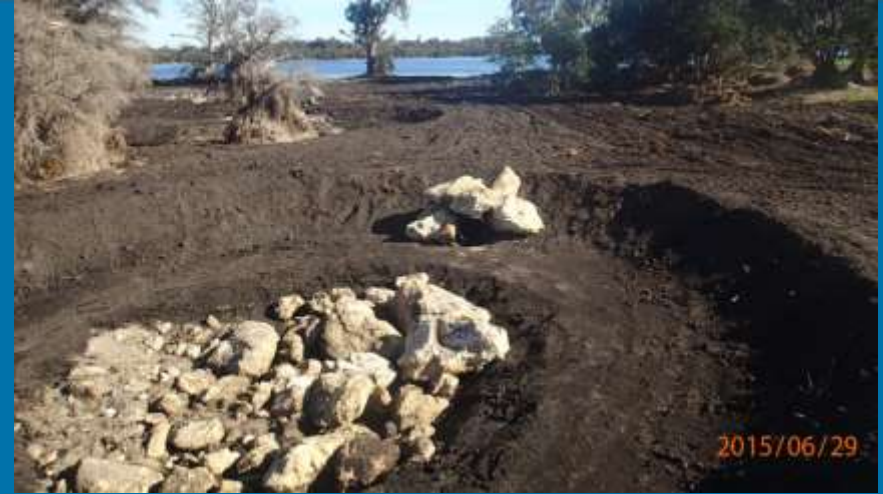
Inlet from lake

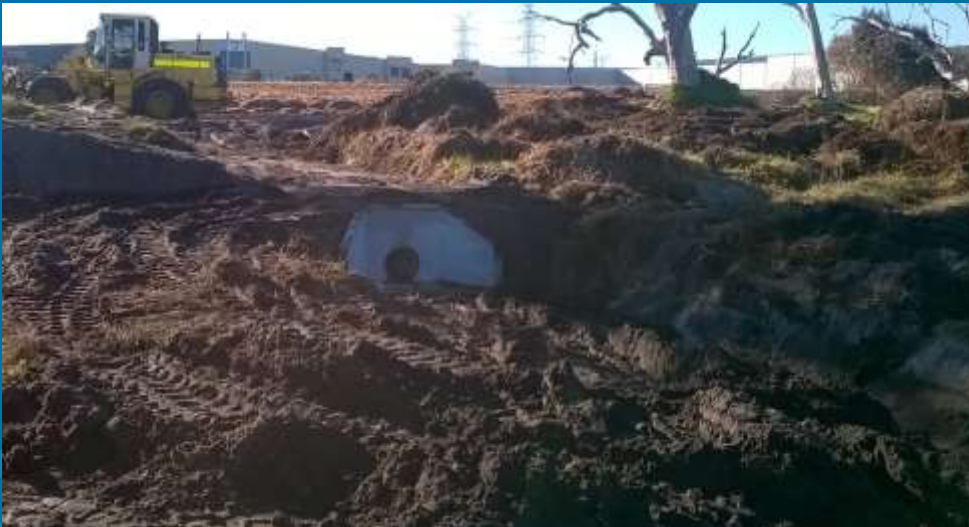
Outlet from grate to  
lake
