CONSTRUCTED LAKES IN THE PERTH METROPOLITAN AREA AND SOUTH WEST REGION

LITERATURE REVIEW AND INTERVIEW PROJECT

Prepared by:	<i>Bronwyn Woodward</i>
Status:	<i>FINAL</i>
QA Review:	<i>Mike Brewis and Paula Austen</i>
Technical Review:	<i>Margaret Dunlop and Karen Lane</i>
Content Review:	<i>Margaret Dunlop and Karen Lane</i>
Date:	<i>6 November 2008</i>

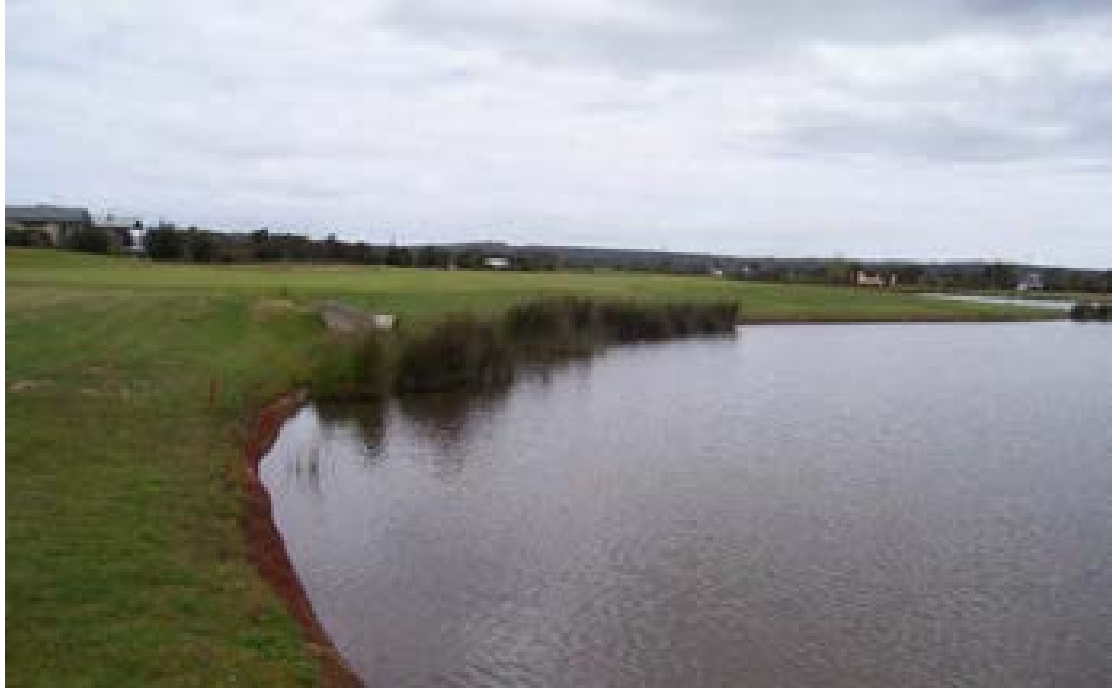
PLATE 1 – The lined lake receives drainage from a golf course to the west.

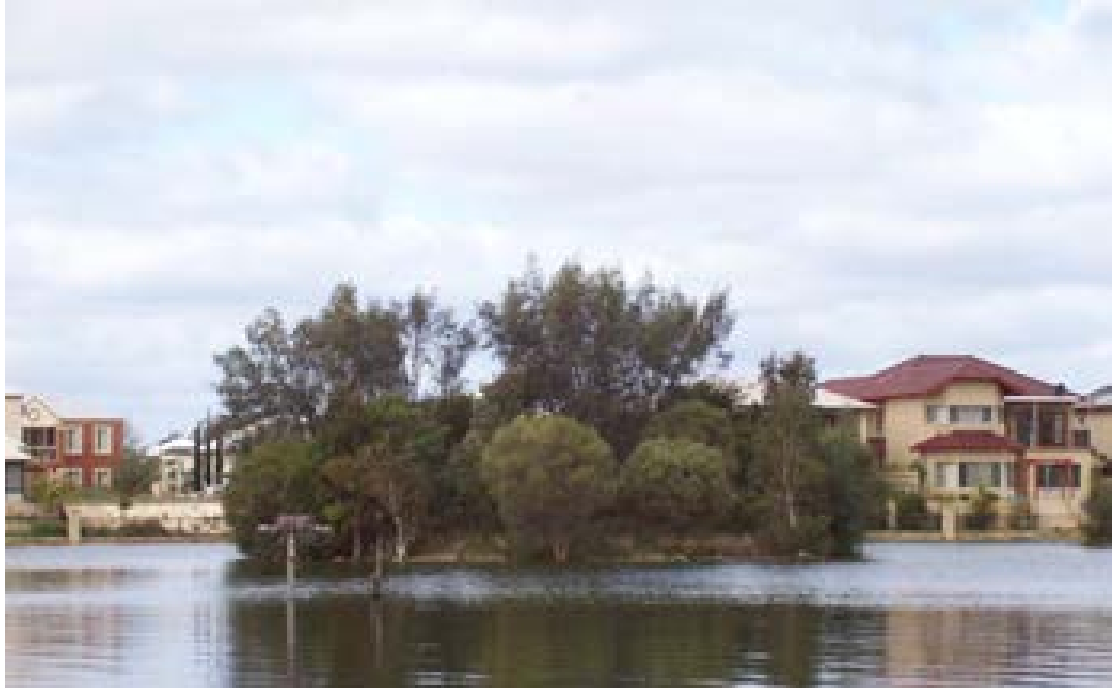
PLATE 1 – Although the lakes are a highly artificial environment surrounded by limestone walls and houses built up to the water's edge, the developer has taken efforts to create fauna habitat through the construction of vegetated islands and roosting poles. Examples of such features in Lake Brearley are shown in the photo above.

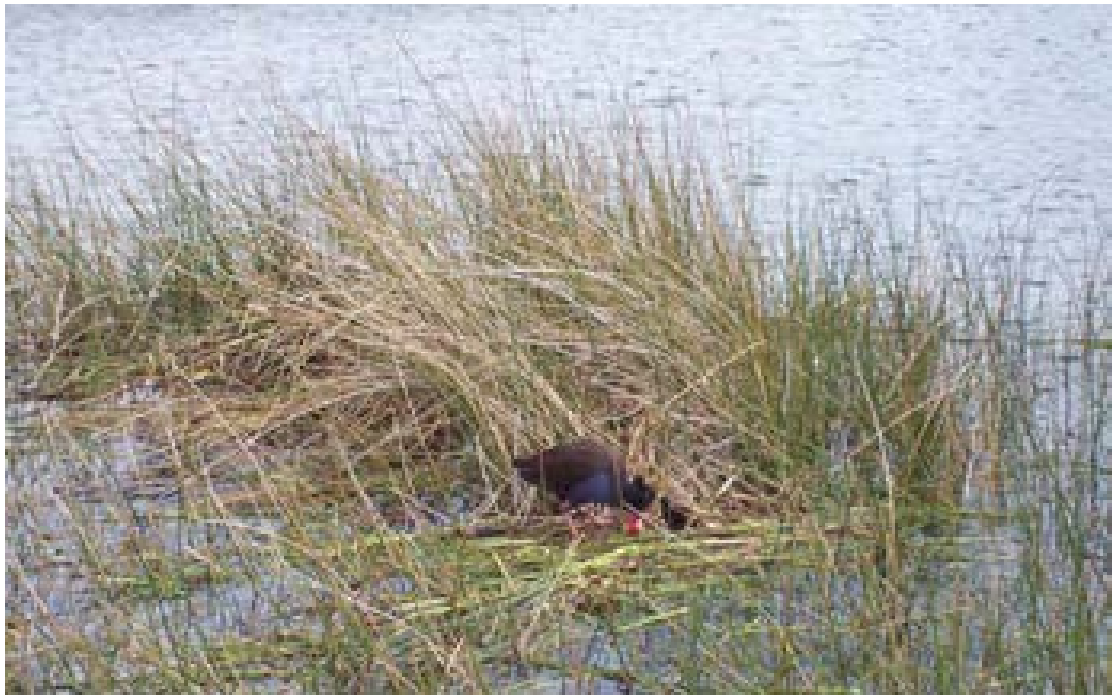
PLATE 2– The lakes were once abandoned clay pits however now they provide a breeding habitat for birds such as this Purple Swamp Hen with its chick observed in Lake Bungana.

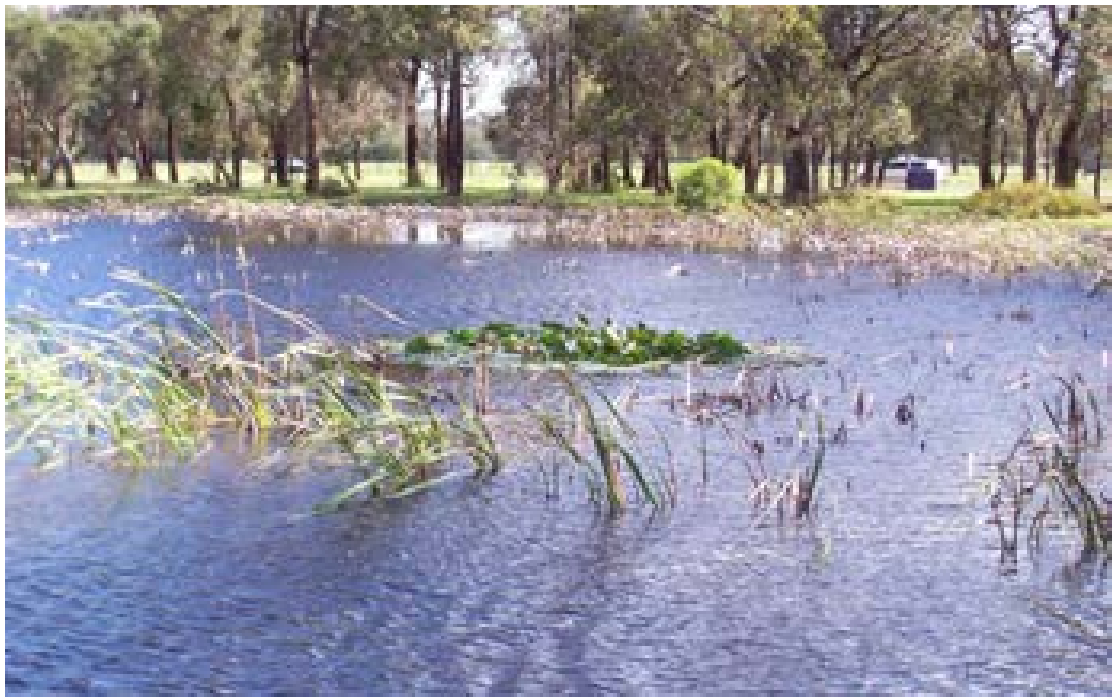
PLATE 2 – The lake has been invaded with *Typha* and an exotic water lily. It is proposed to develop farmland to the west of the lake, in background of photo, which is likely to increase the aesthetic importance of the lake.

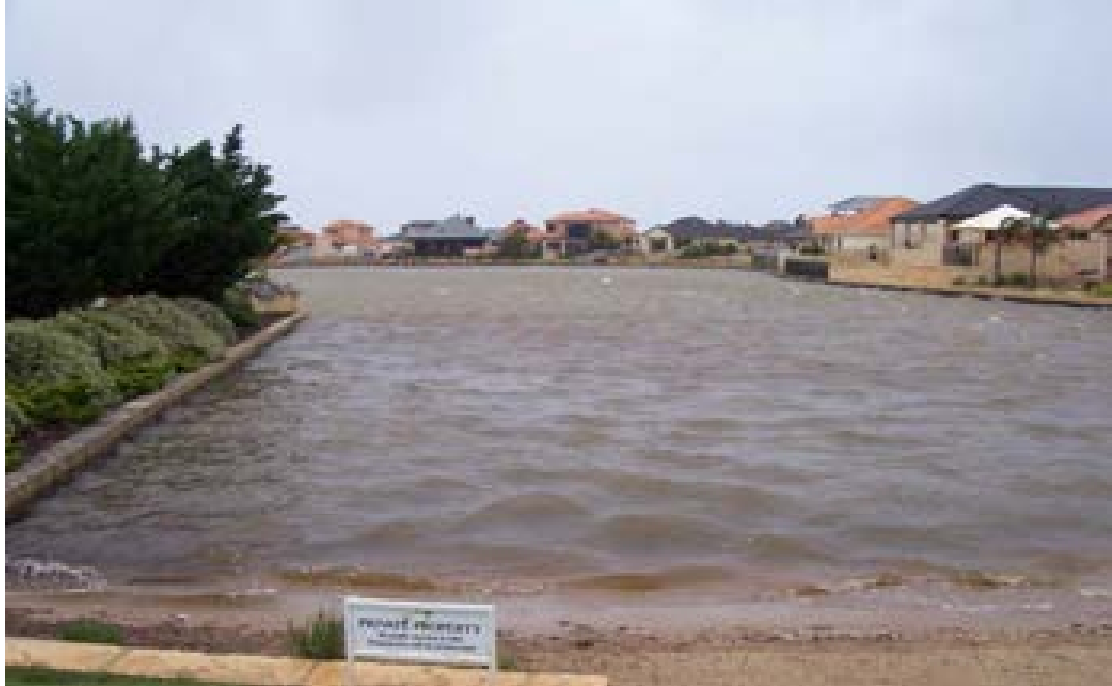
PLATE 1 – The lake is privately owned by the local residents

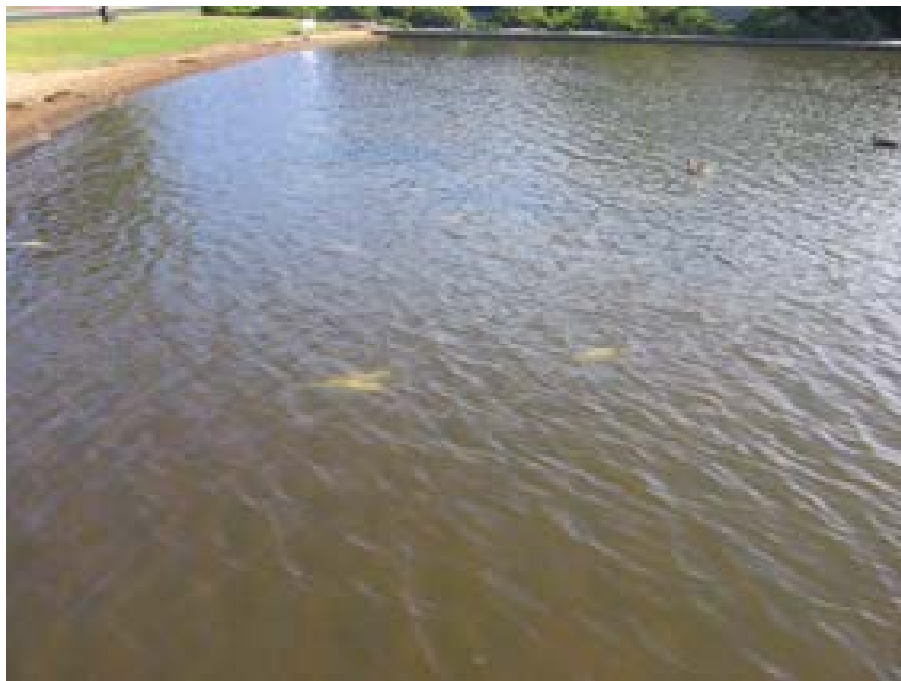
PLATE 2 – Fish kills in the lake in spring 2006 (provided by City of Bunbury)

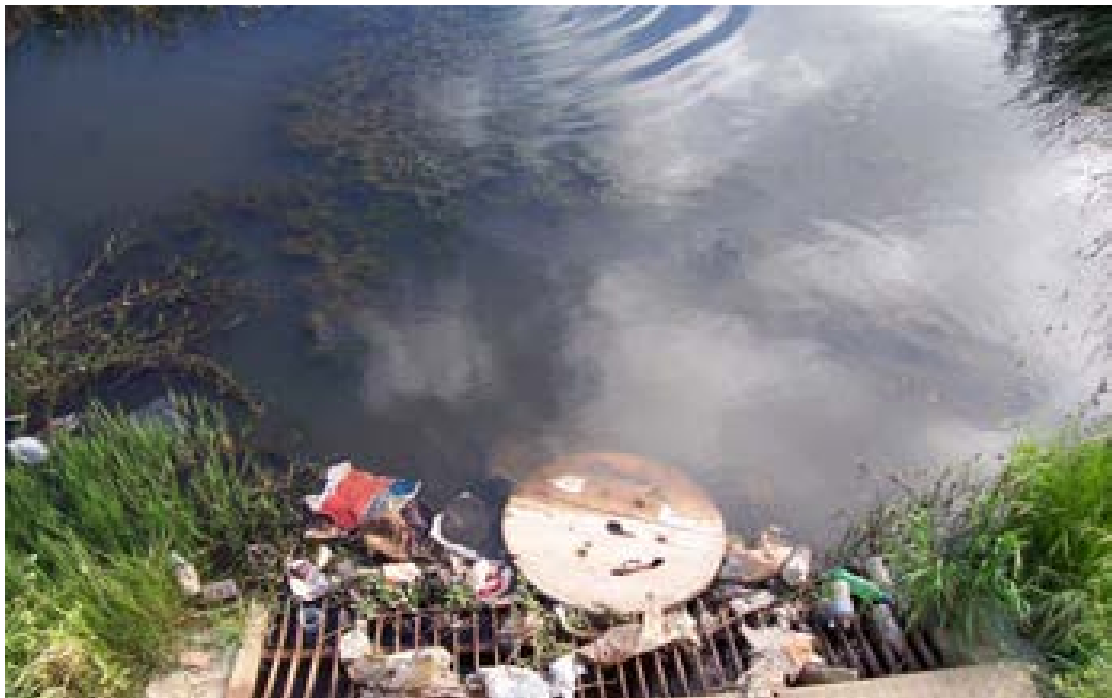
PLATE 2 – Rubbish collecting around the lake outlet.

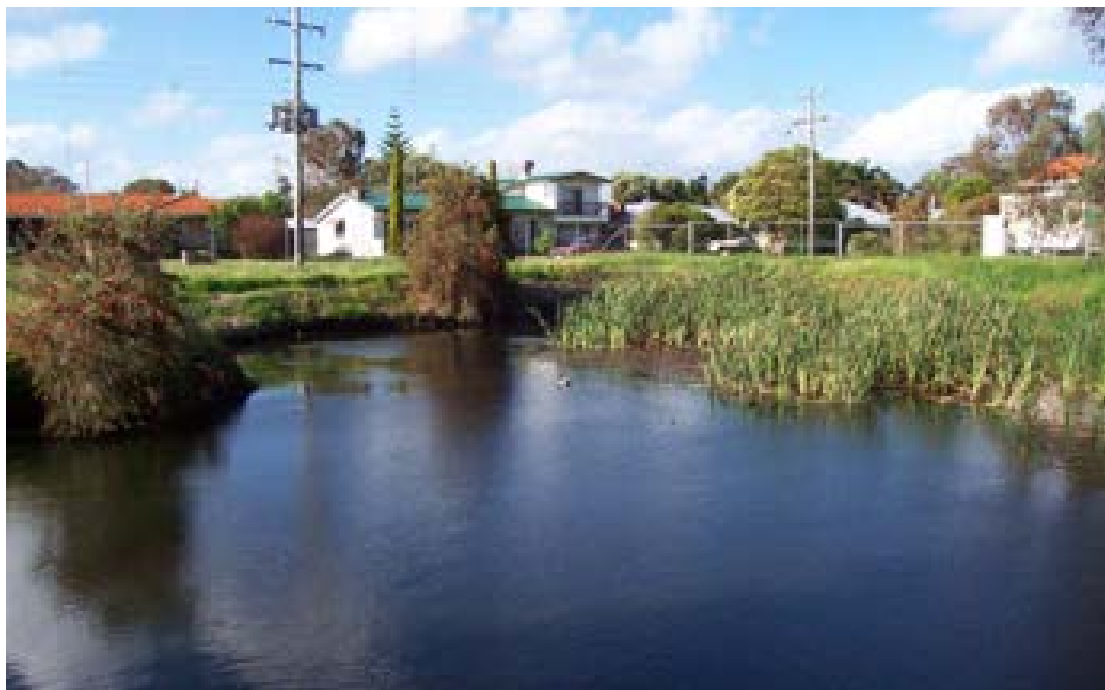
PLATE 1 – Residents would like to see the visual appearance of the lake improved.

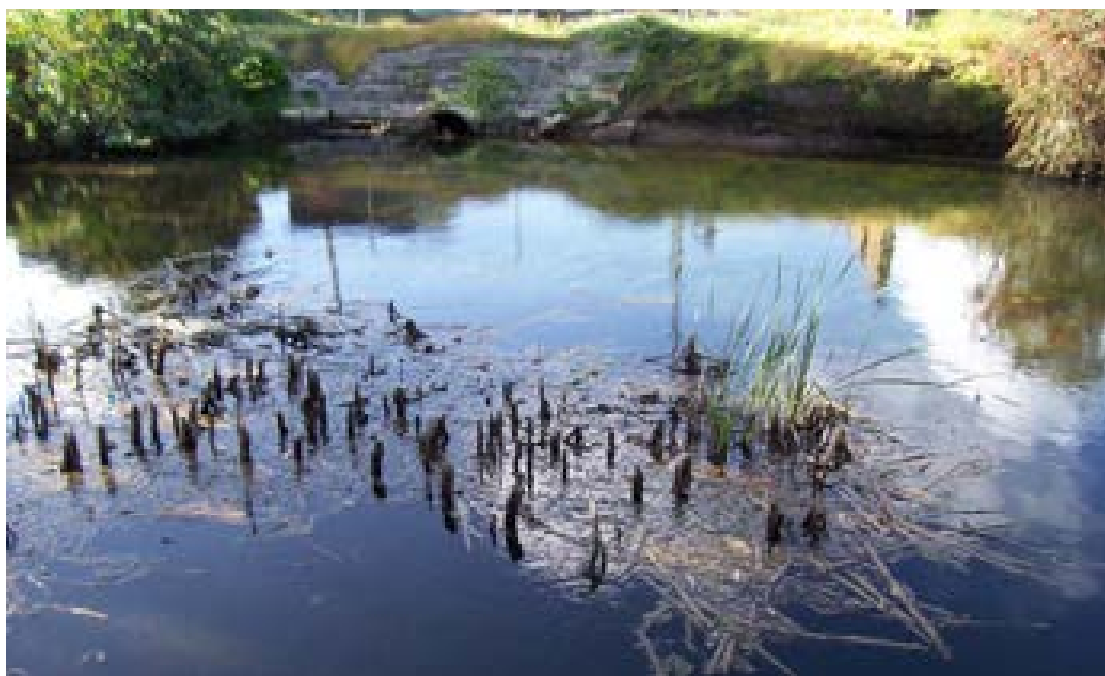
PLATE 2– Typha invasion is a problem in the lake. In some areas it has been manually removed.

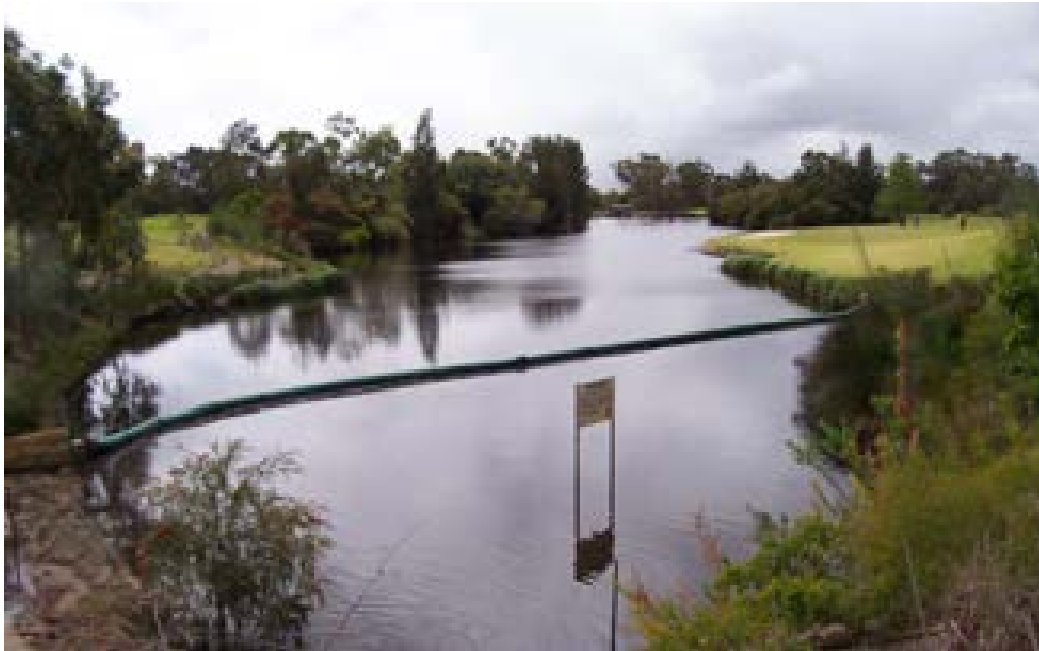
PLATE 1 – A boom installed was installed at the lake inlet in 2006 to collect oil/particulate matter in incoming industrial drainage.

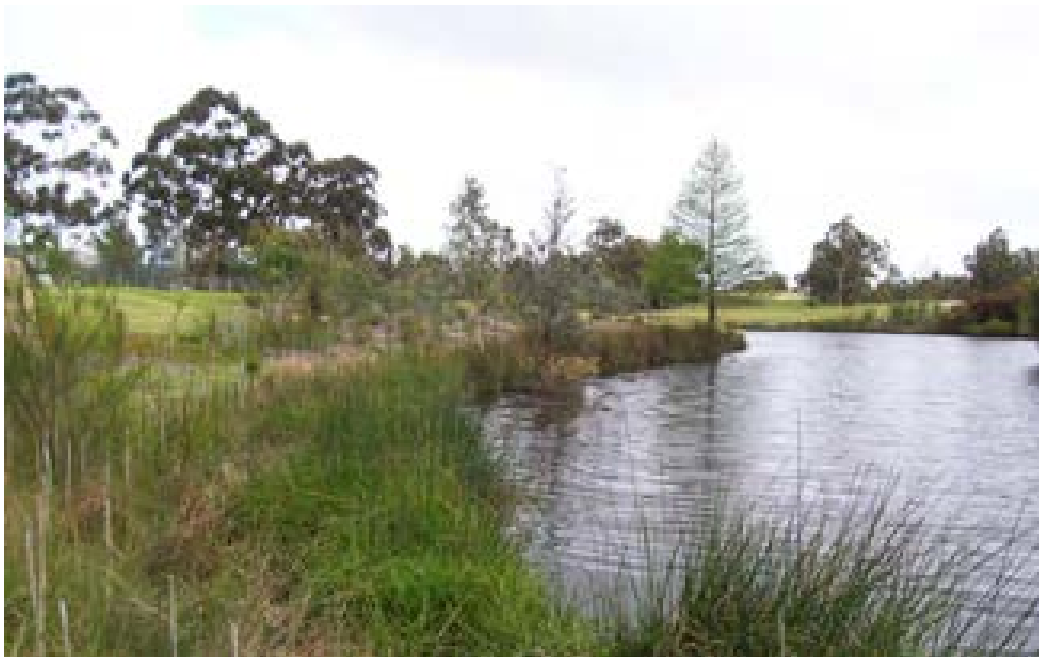
PLATE 2 – The South East Regional Centre of Urban Landcare (SERCUL) has undertaken revegetation works to improve the fringing vegetation around the lake.

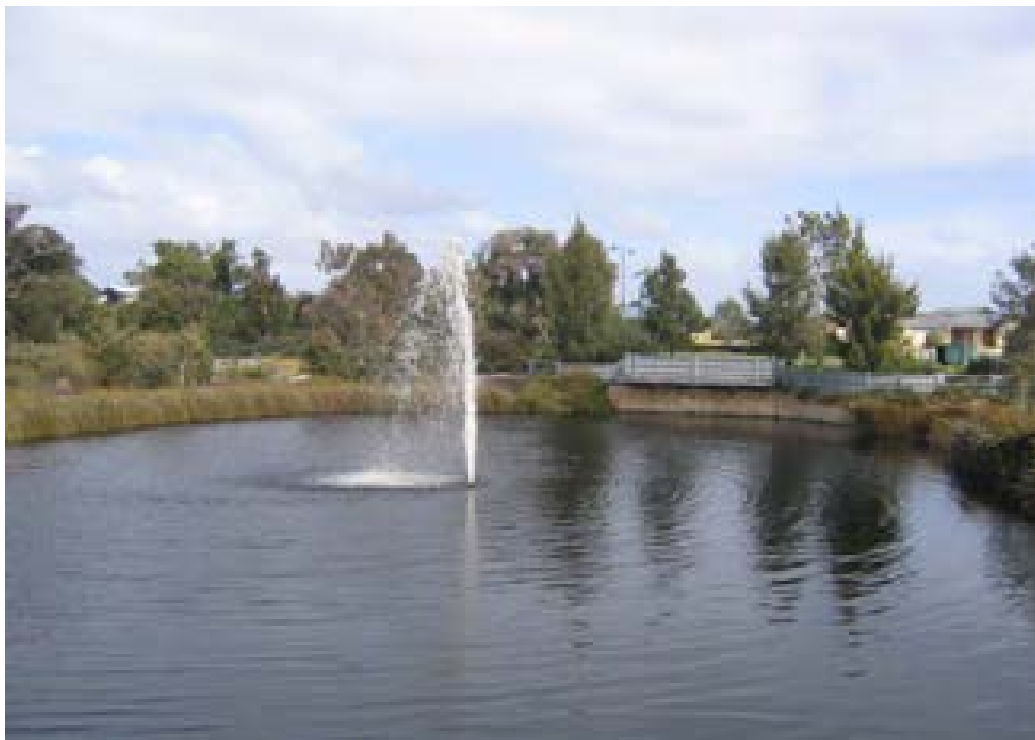
PLATE 1 – The eastern lake has a more ornamental appearance than the western lake.

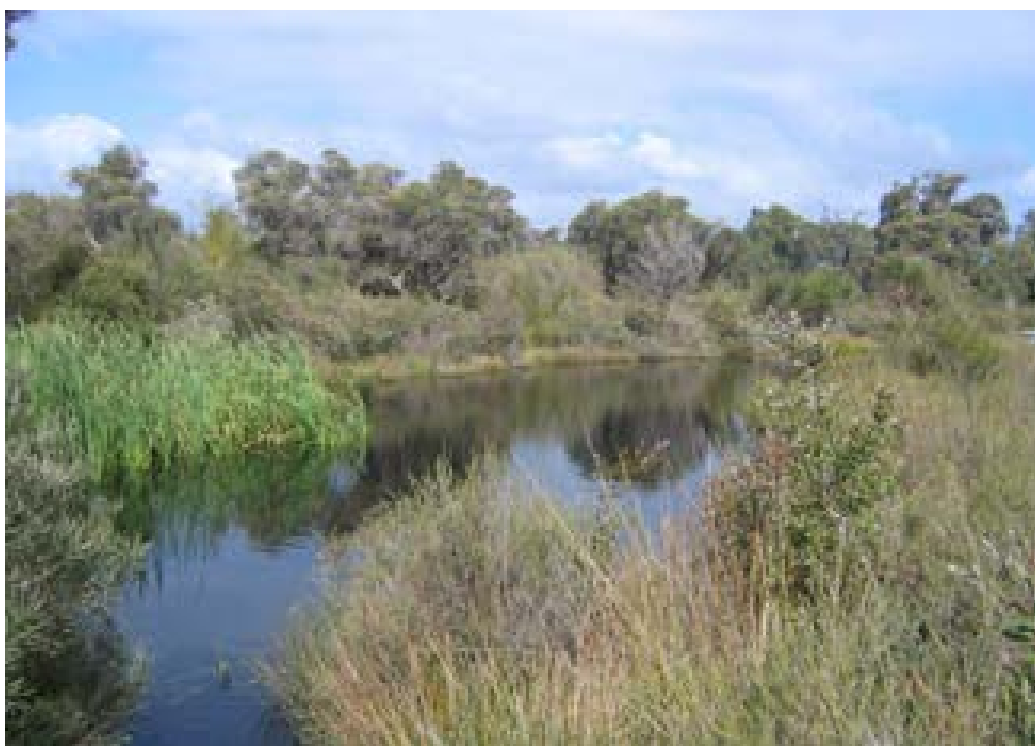
PLATE 2 – Natural vegetation surrounding the western lake. Some *Typha* is visible in the left side of the photograph.

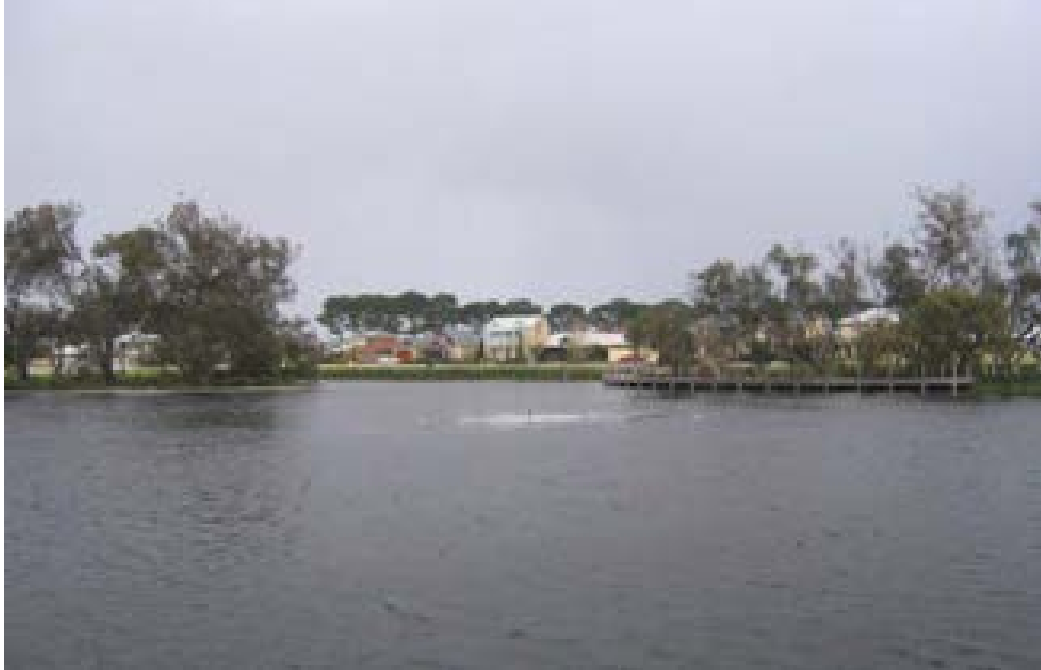
PLATE 1 – The lake is surrounded by some native vegetation. An aerator is visible in the foreground and the 'GreenSmart Village' residential development in the background.

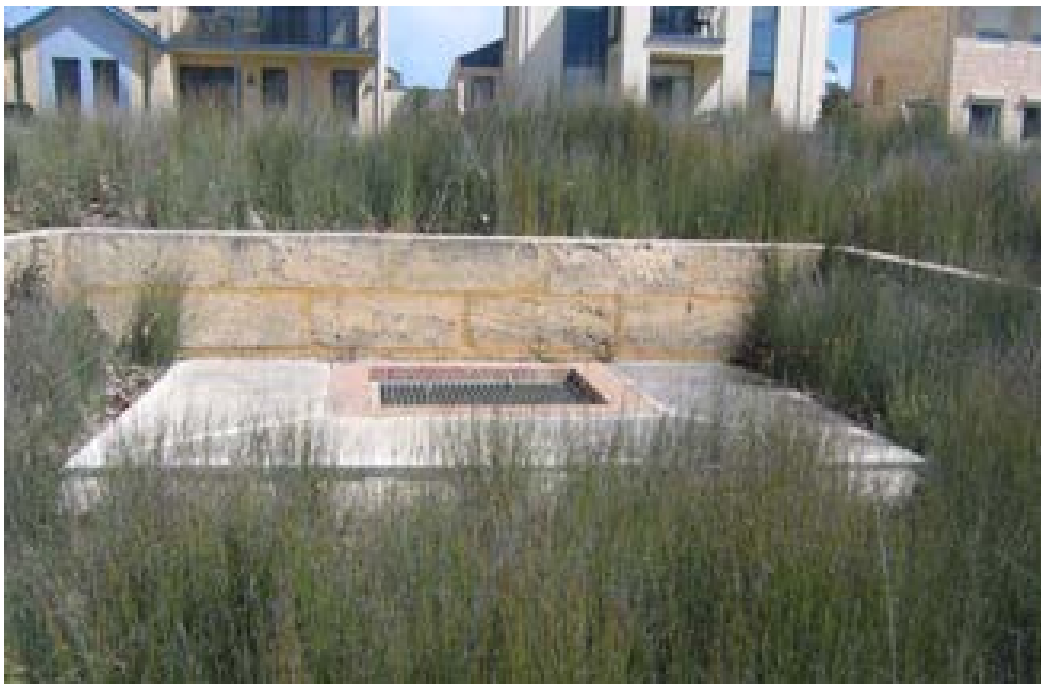
PLATE 2– Drainage enters the lake via bubble ups and reed beds.

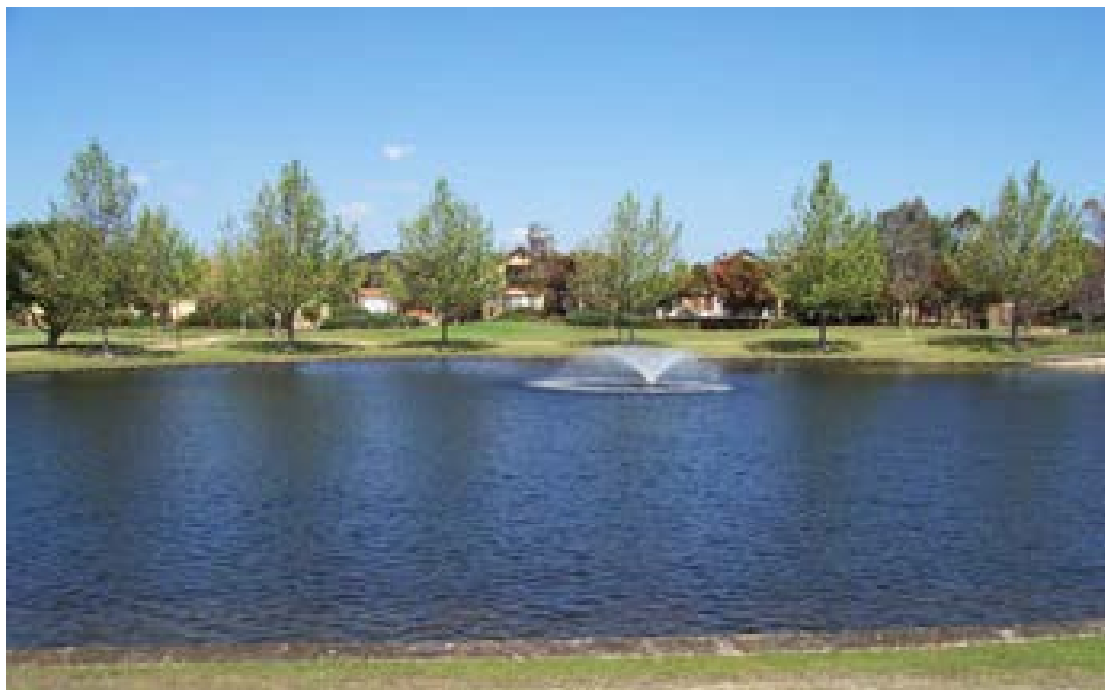
PLATE 1 – The lake is in close proximity to residential housing and has received occasional complaints about mosquitos and midges.

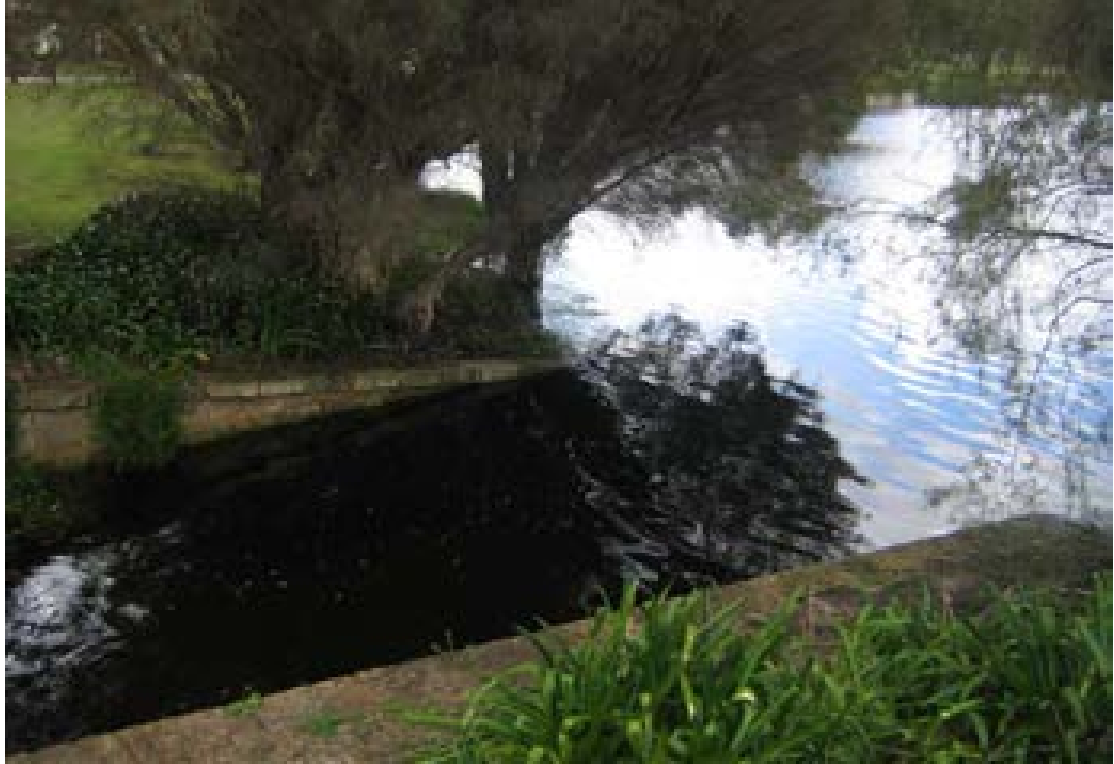
PLATE 1 – Nutrient rich stormwater flows from Sandringham 2 Lake to the Prior Close Reserve Lake.

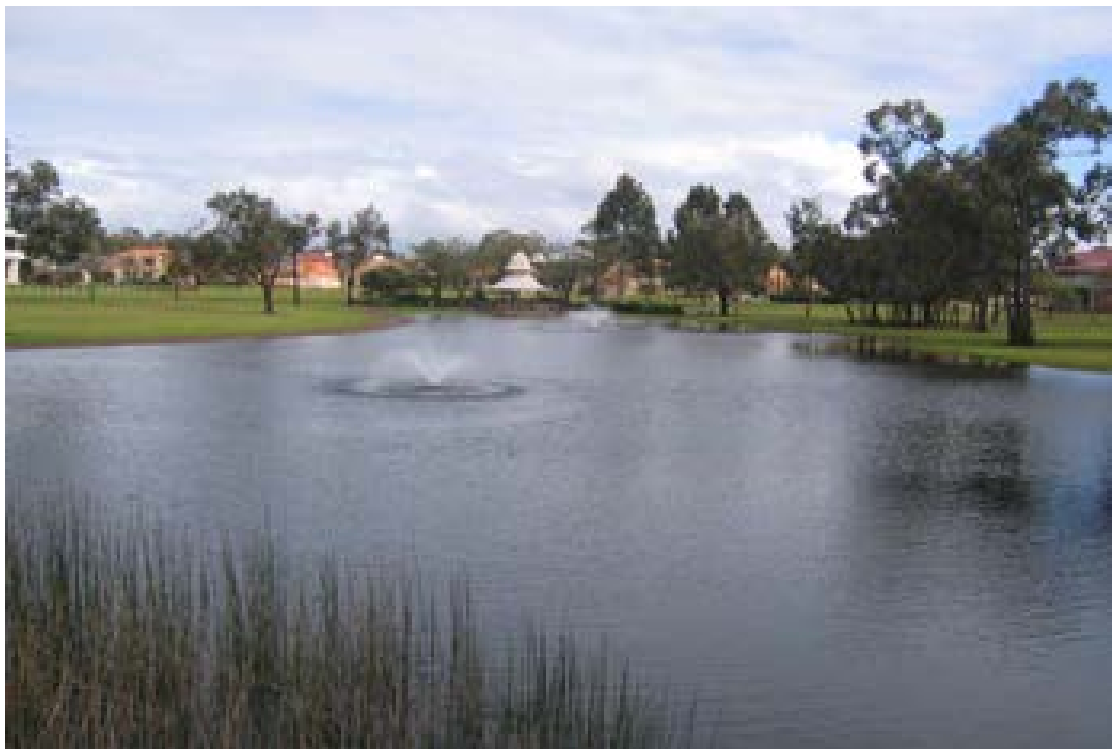
PLATE 4 – Sandringham Reserve 1, the top irrigation lake in the Brookland Greens chain, does not receive stormwater inflows and does not have problems with algal blooms or midges.

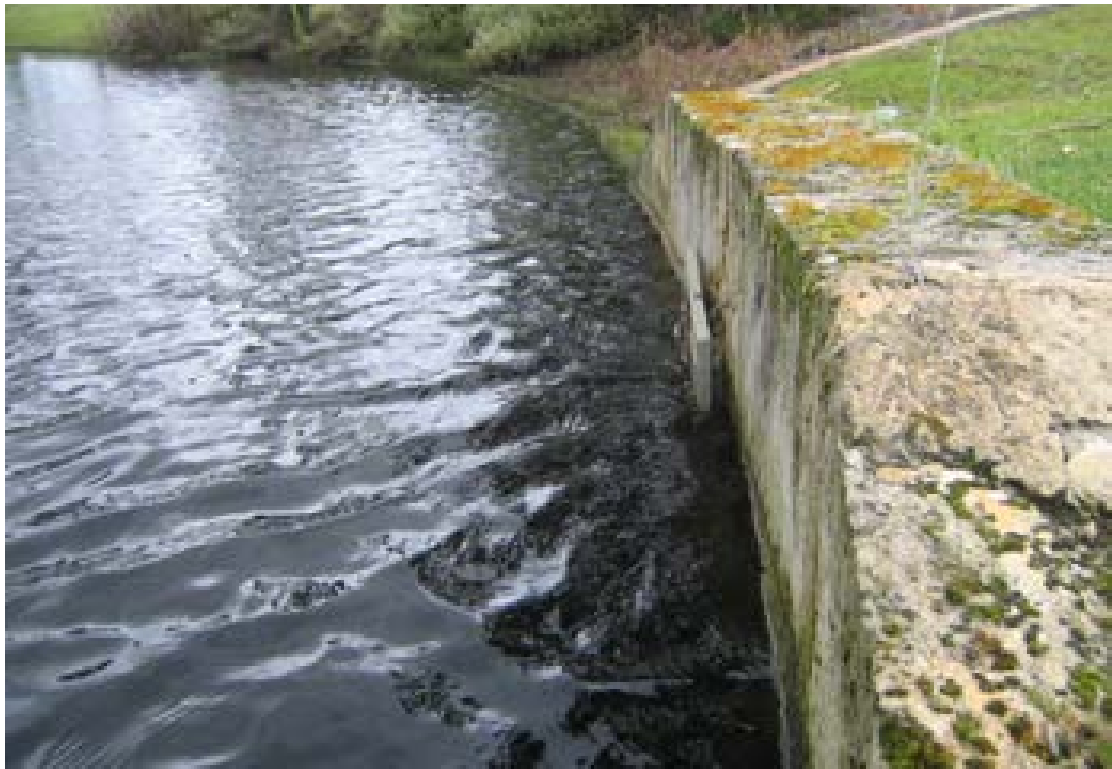
PLATE 2 – Outlet to the Canning River.

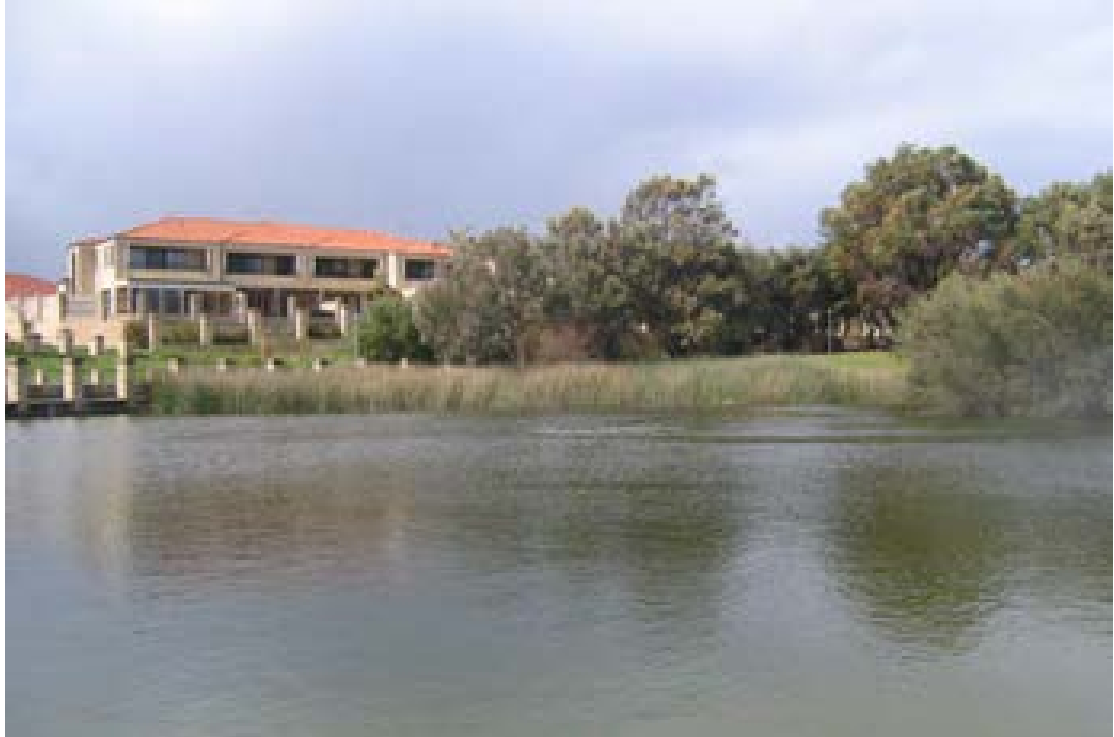
The Central Lake has experienced several blooms of unicellular green algae as well as a blue green algal bloom in the 2006/2007 summer. A submerged aerator was installed in the lake following the blue green algal bloom however it is not known whether this was successful in reducing algal blooms the following summer. A volcanic ash product was also trialed to reduce algal blooms however according to the lake manager this appeared to have no observed effect on algal levels.

PLATE 1 – The Central Lake has experienced several algal blooms. The water had a slight green tinge when visited in September 2007.

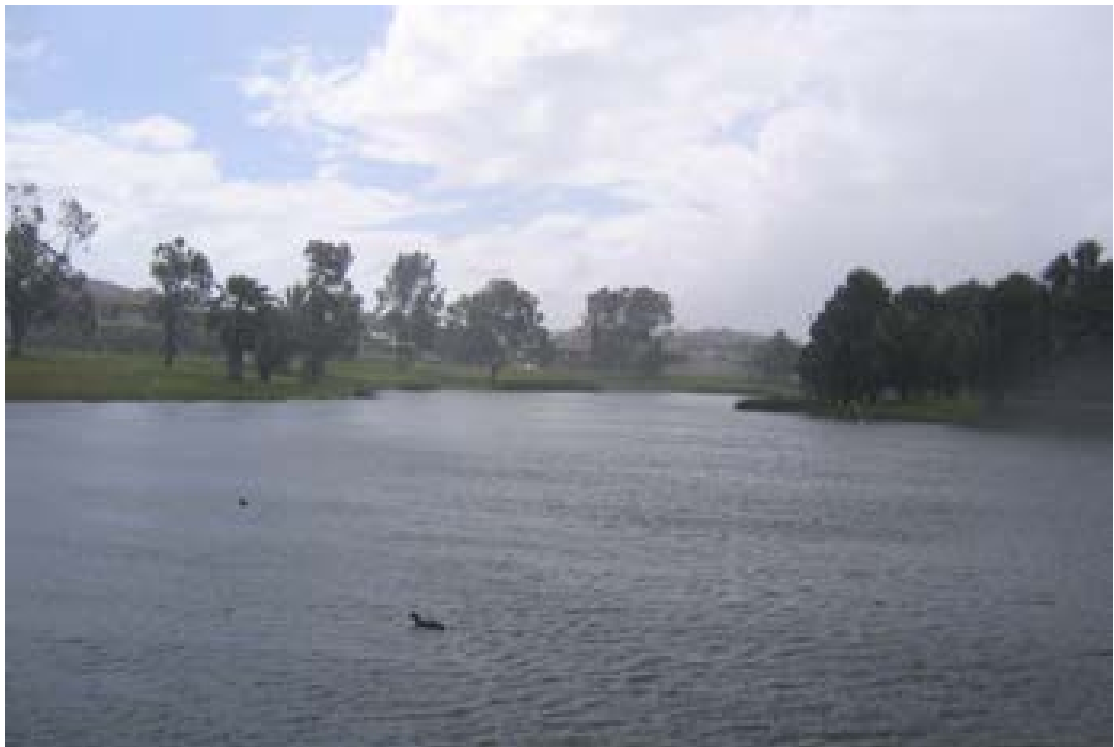
PLATE 2 – The North Lake has only experienced minor issues with nuisance algal growth.

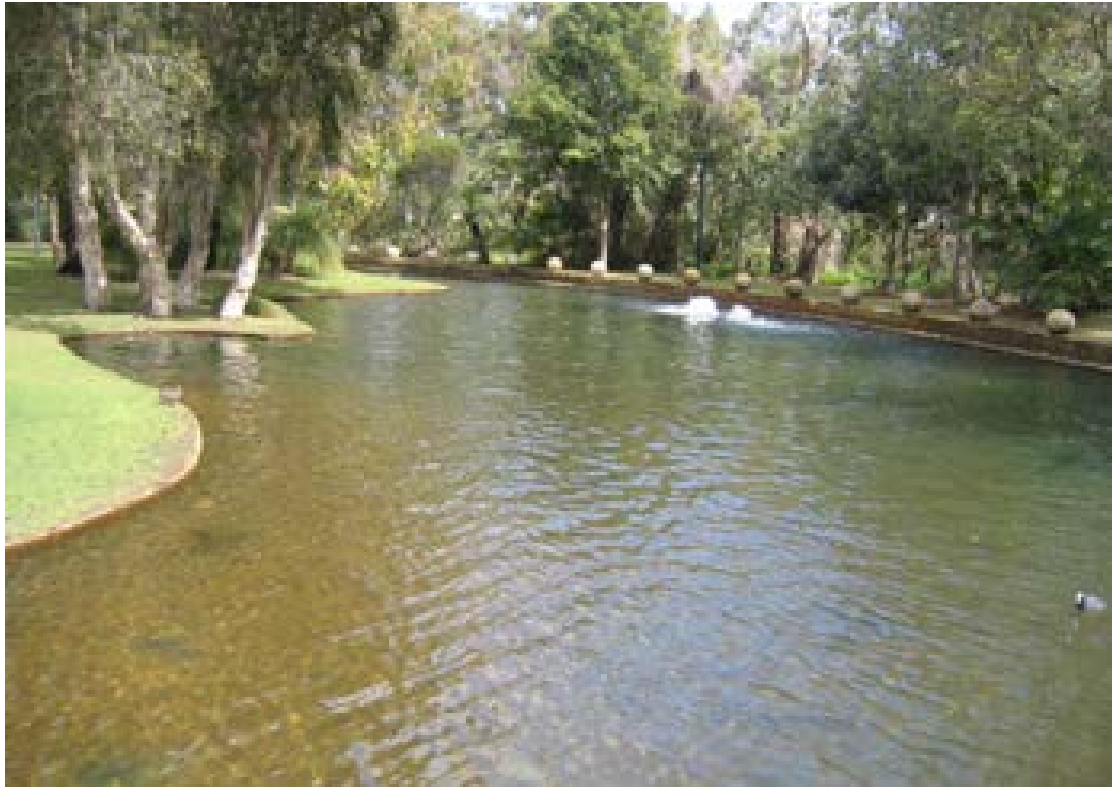
PLATE 1 – One of the submerged aerators installed at the lake to oxygenate a shallow stagnant section of the lake.

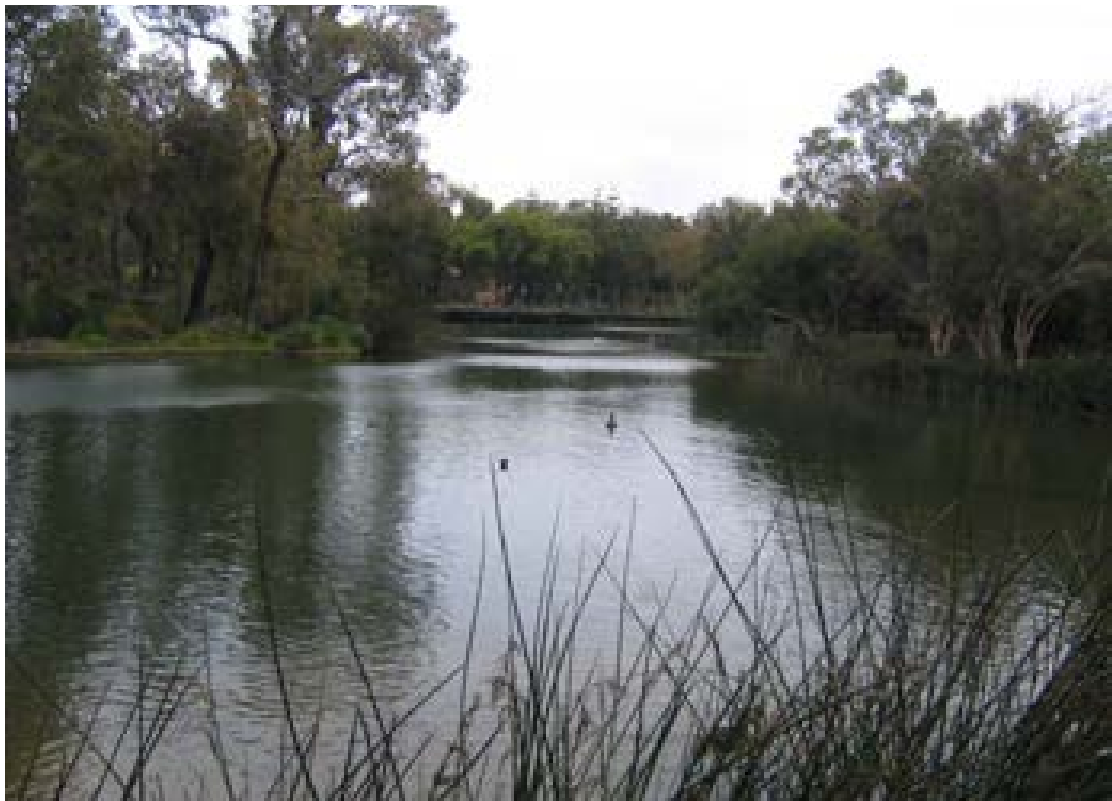
PLATE 2 – Reeds were planted around the lake with the intention of stripping nutrients to prevent algal blooms.

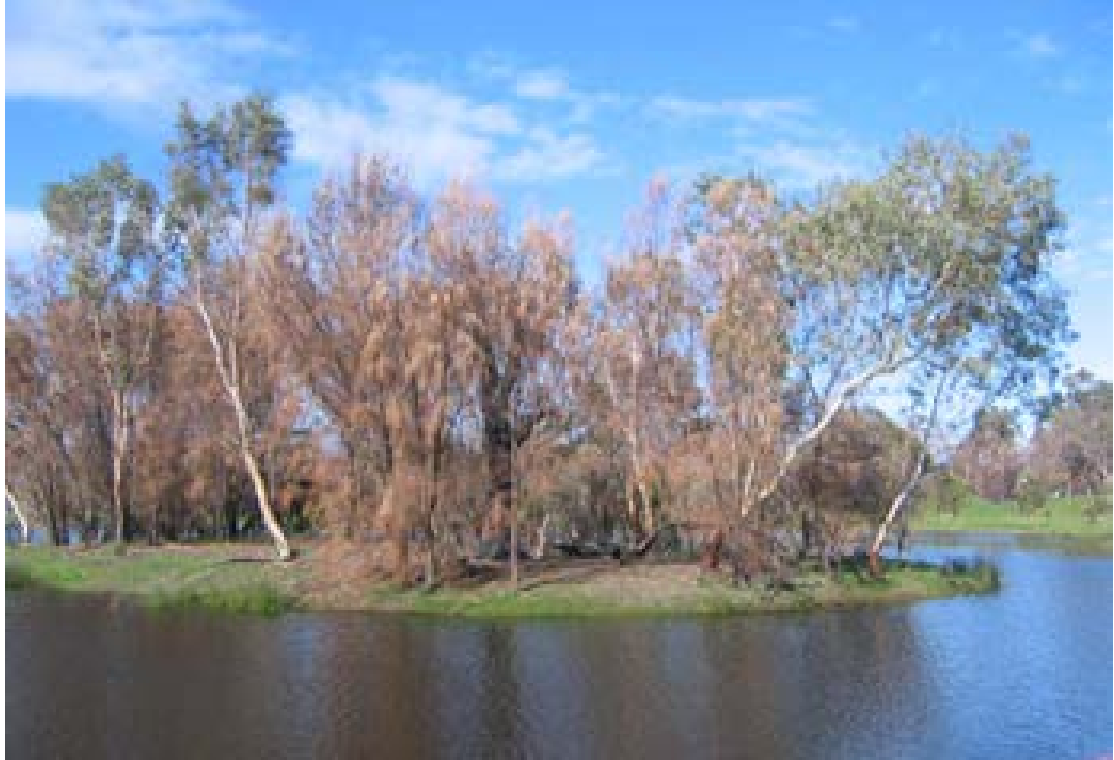
Due to nutrient enrichment, blooms of macroalgae and on occasions blue green algae have been an issue since the late 1990s. Dewatering for the Port Mandurah canal development to the north of the site caused the lake to almost dry up in summer approximately three years ago. The fall in water levels and possibly saline intrusion resulted in the death or harm to much of the lake's fringing vegetation which was further damaged by a bad fire last summer.

PLATE 1 – Vegetation death resulting from fire.

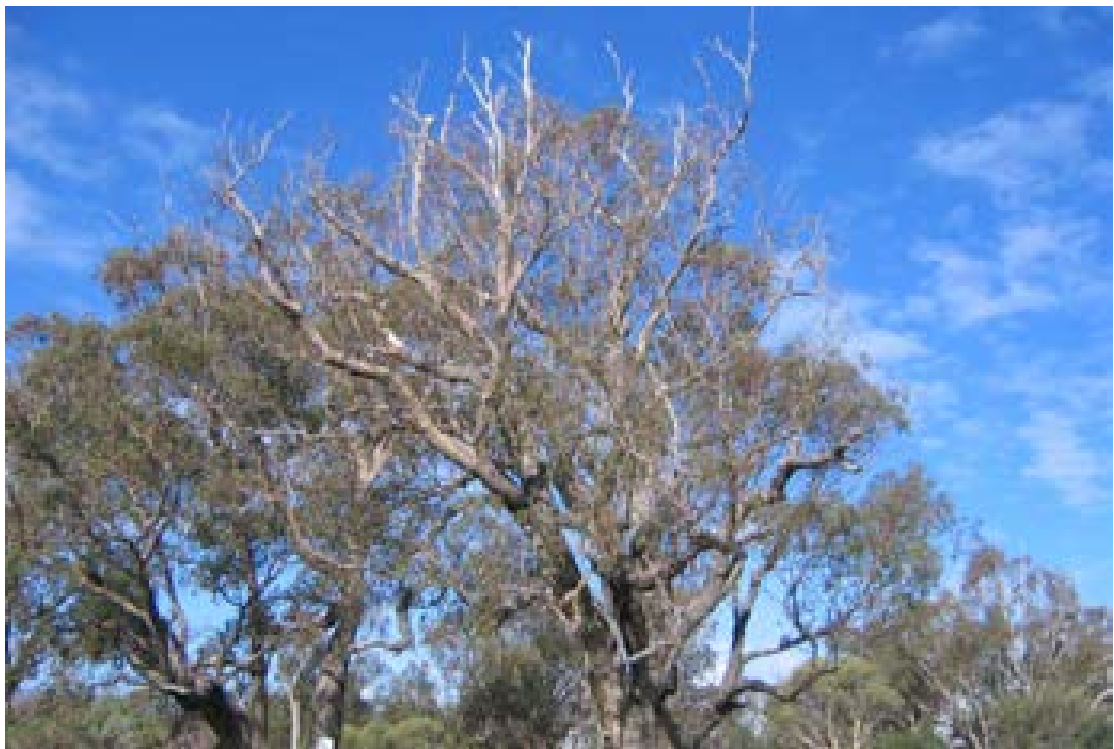
PLATE 2 – Vegetation death resulting from dewatering.

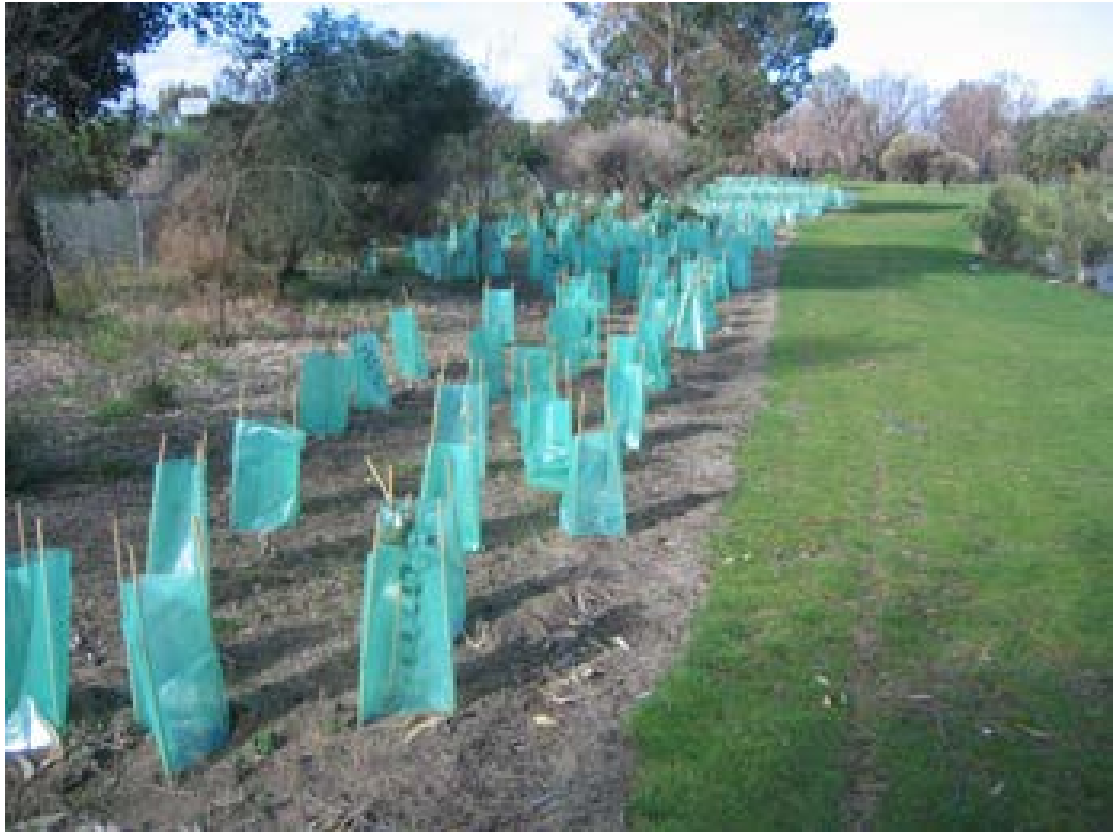
PLATE 3 – Arbour day planting of native vegetation around the lake.

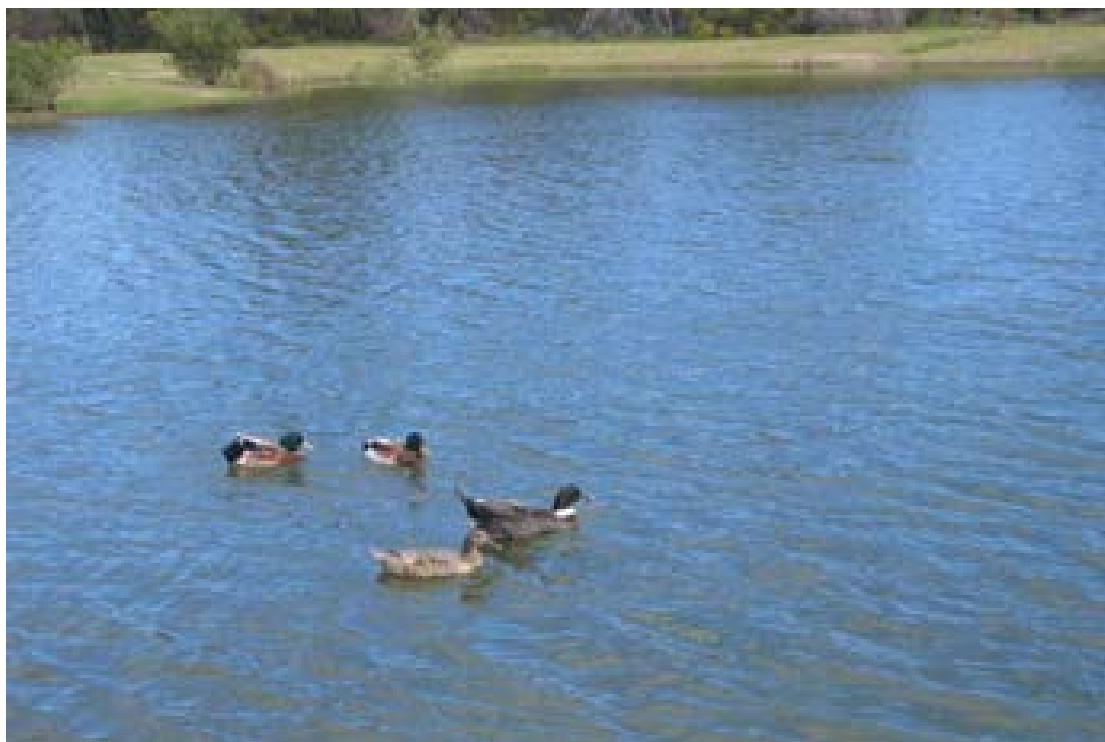
PLATE 2 – Ducks in the northern lake. *Typha* is visible growing on the southern bank of the lake.

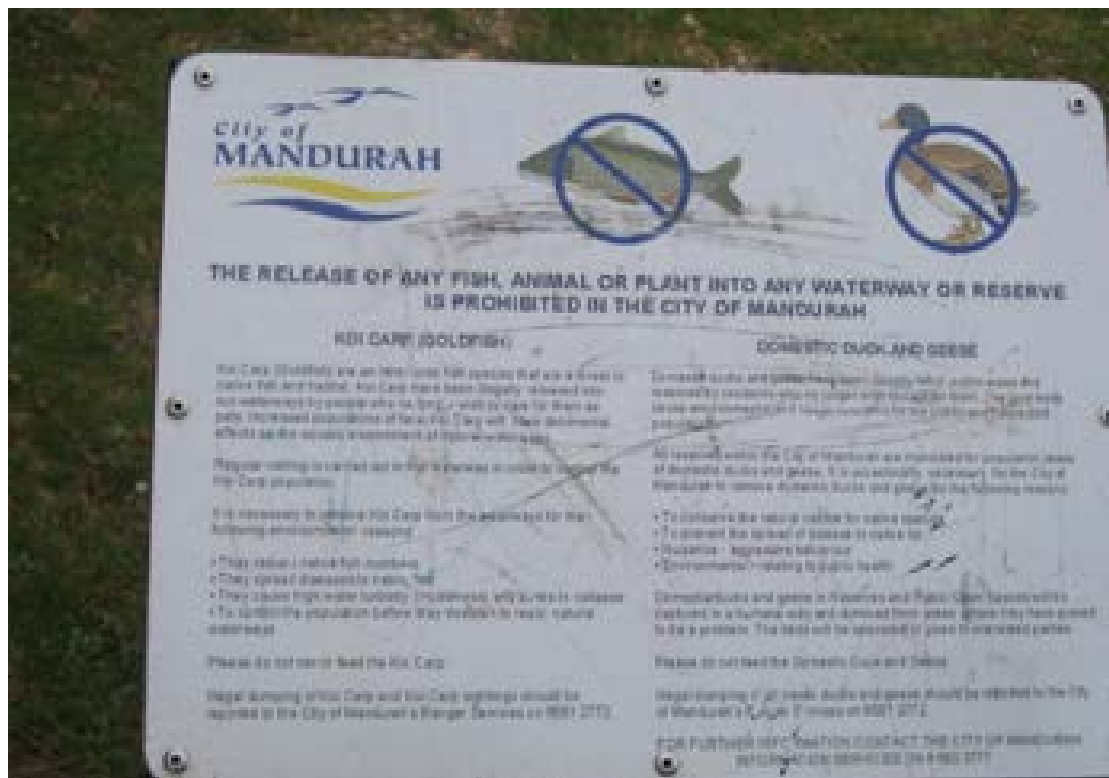
PLATE 2 – Netting complemented by public education through methods such as signage (above) was successful in eliminating Koi Carp from the lake.
