CONSTRUCTED LAKES IN THE PERTH METROPOLITAN AREA AND SOUTH WEST REGION

LITERATURE REVIEW AND INTERVIEW PROJECT

Prepared by:	<i>Bronwyn Woodward</i>
Status:	<i>FINAL</i>
QA Review:	<i>Mike Brewis and Paula Austen</i>
Technical Review:	<i>Margaret Dunlop and Karen Lane</i>
Content Review:	<i>Margaret Dunlop and Karen Lane</i>
Date:	<i>6 November 2008</i>

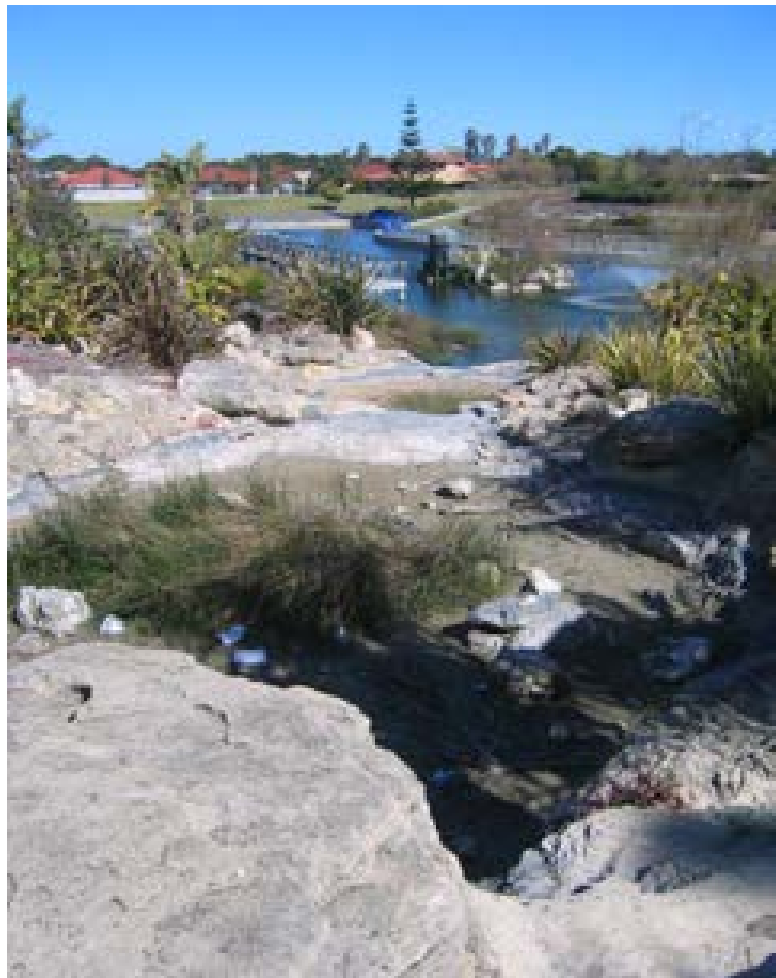
PLATE 1 – The lake recirculation system was not operating in September 2007, although the two fountains in the lake were working.

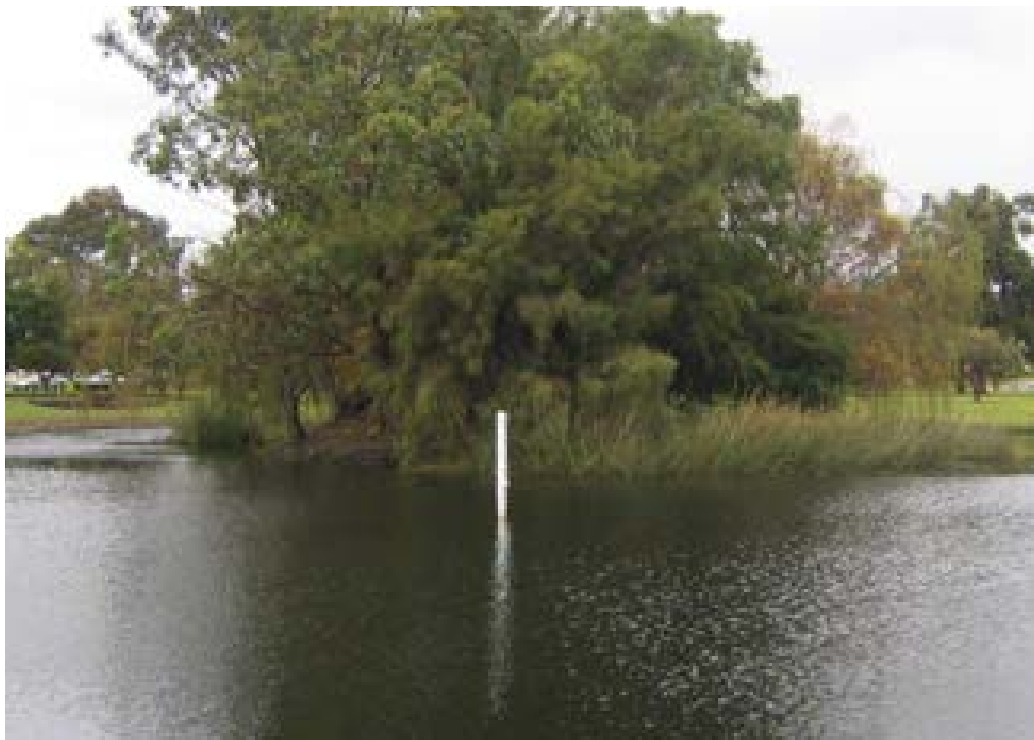
PLATE 1 – Following lining with clay the lake now retains permanent water.

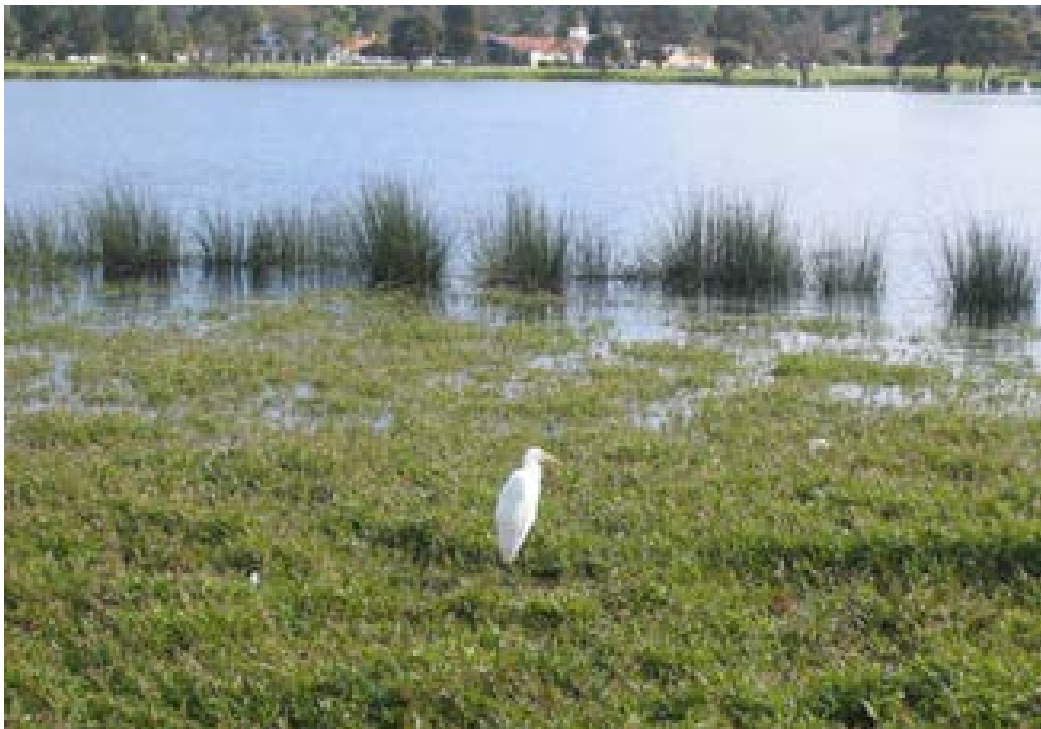
PLATE 2 – Reeds have been planted around the lake to reduce nutrient levels in the lake and improve its habitat value.

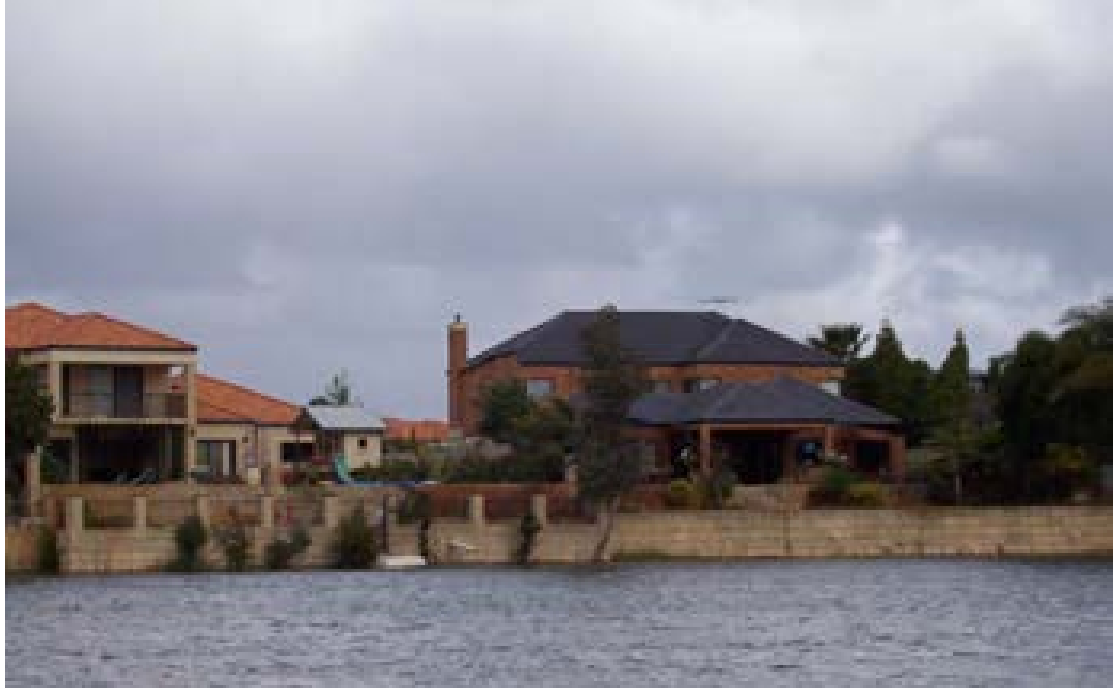
PLATE 1 – Residential housing surrounding the lake. Subsoil drainage from residential lawns discharges directly into the lake.

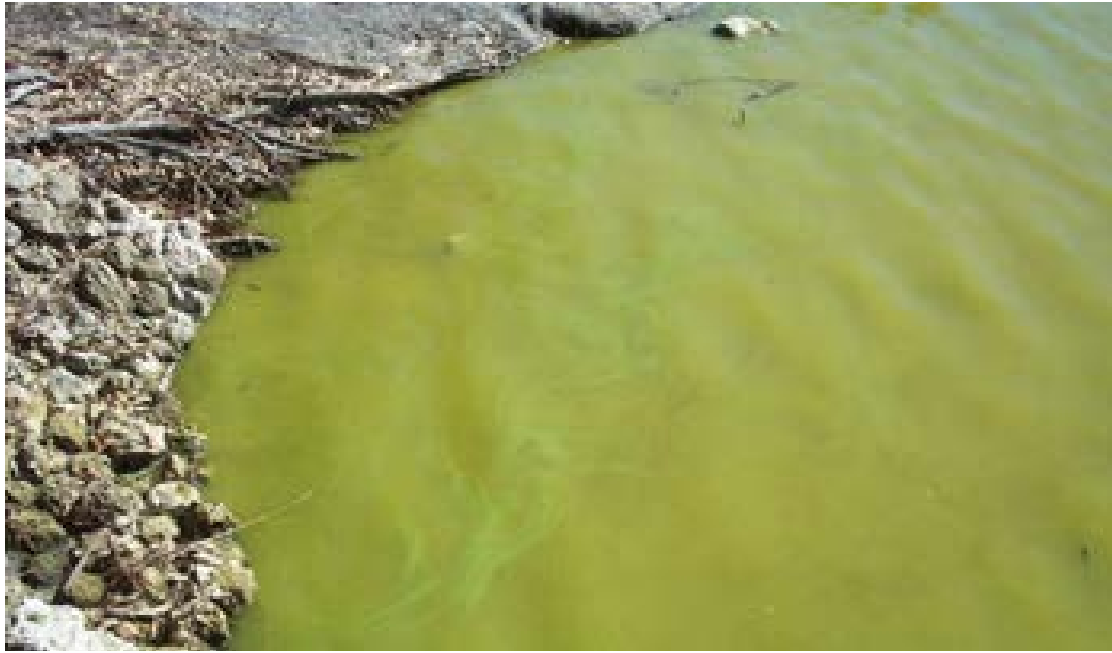
PLATE 3 – *Microcystis* bloom in August 2006 (ENV, 2008). This algae forms bright green scum in still water.

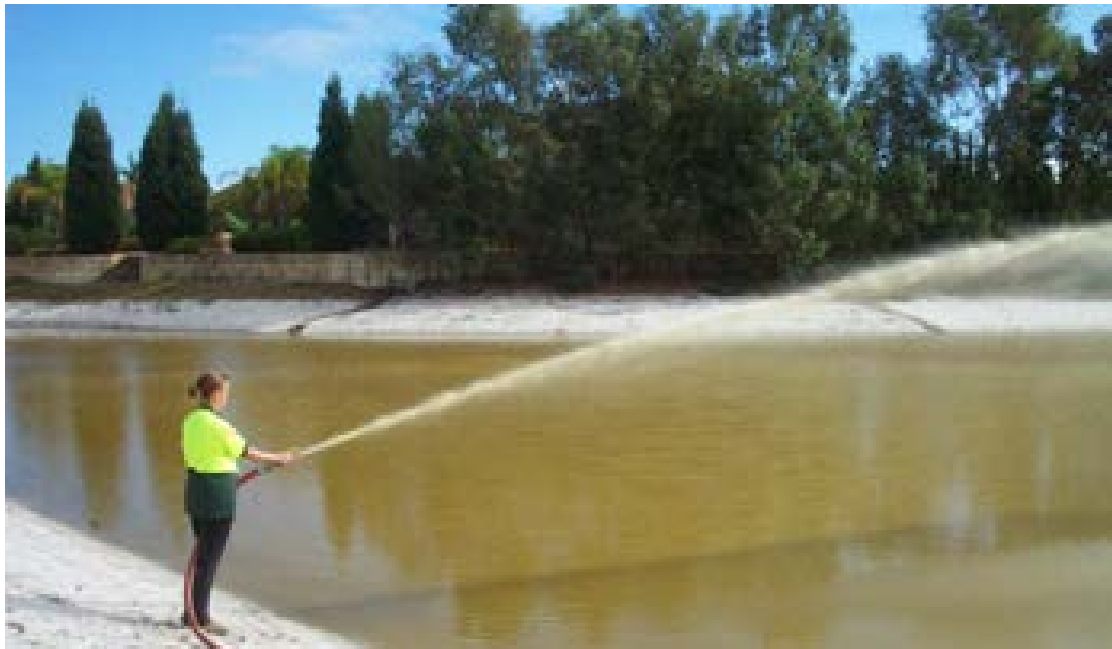
PLATE 4 – Applying Phoslock to the lake in April 2007 (ENV, 2008).

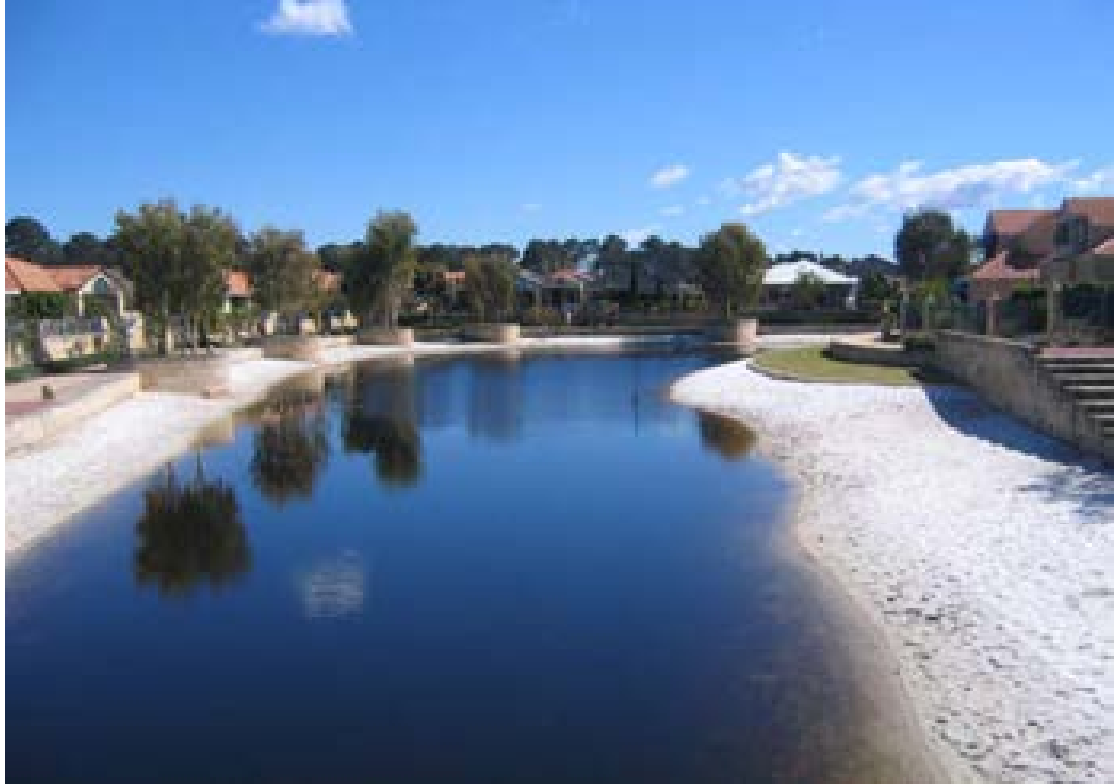
PLATE 1 – At the beginning of Spring 2007, the water levels were well below the design level (the walls of the lake).

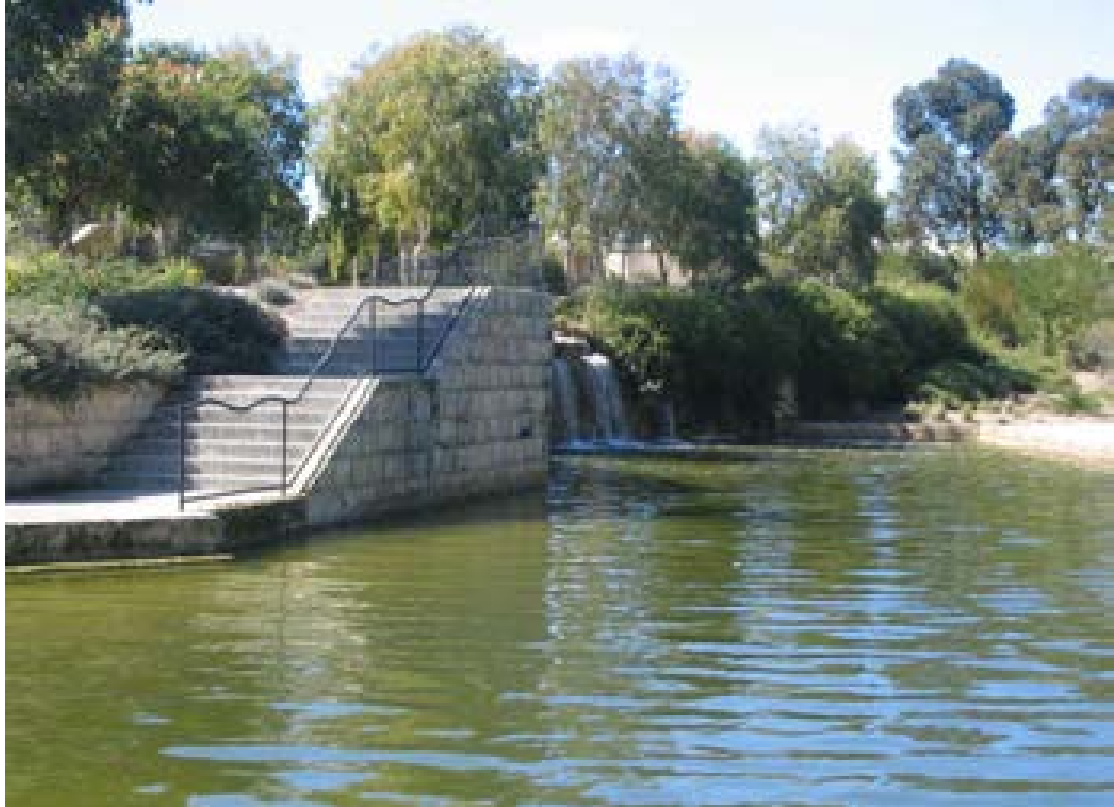
PLATE 1 – Water is recirculated through the lake over a waterfall. The water appeared green in September 2007 indicating high levels of microalgae was present.

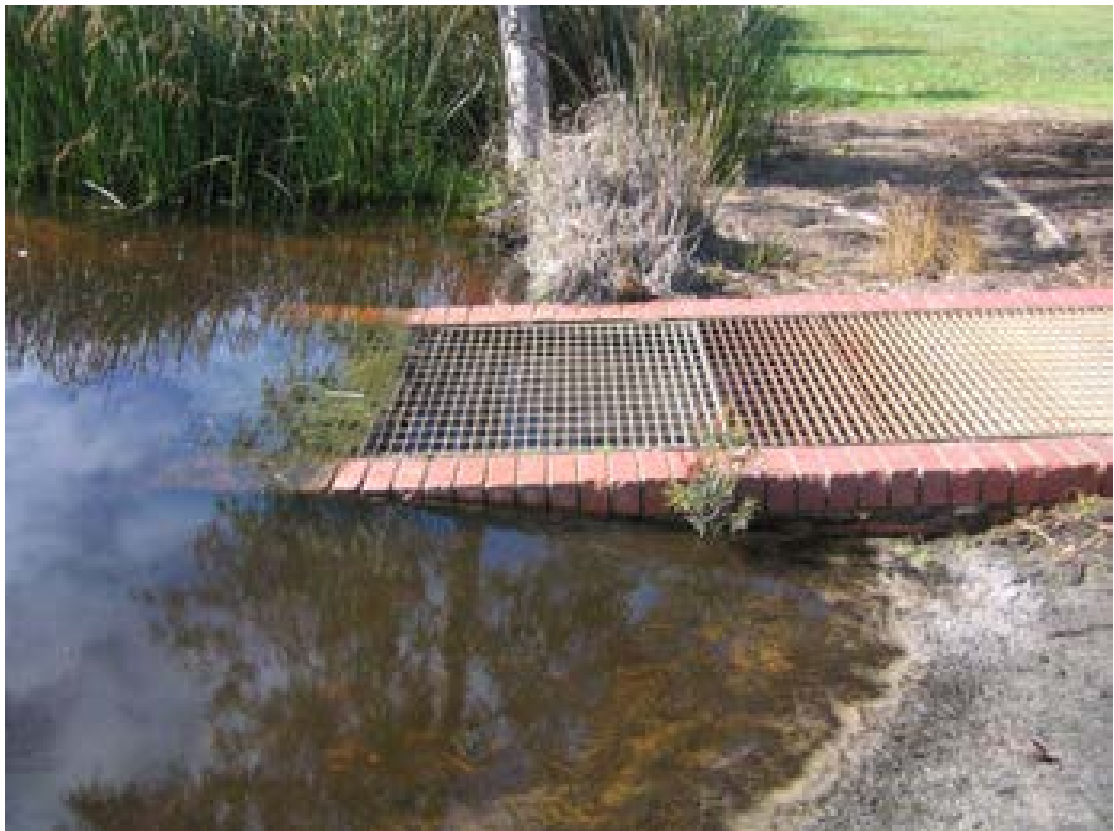
PLATE 2 – The inlet of the single stormwater drain that discharges into the lake.

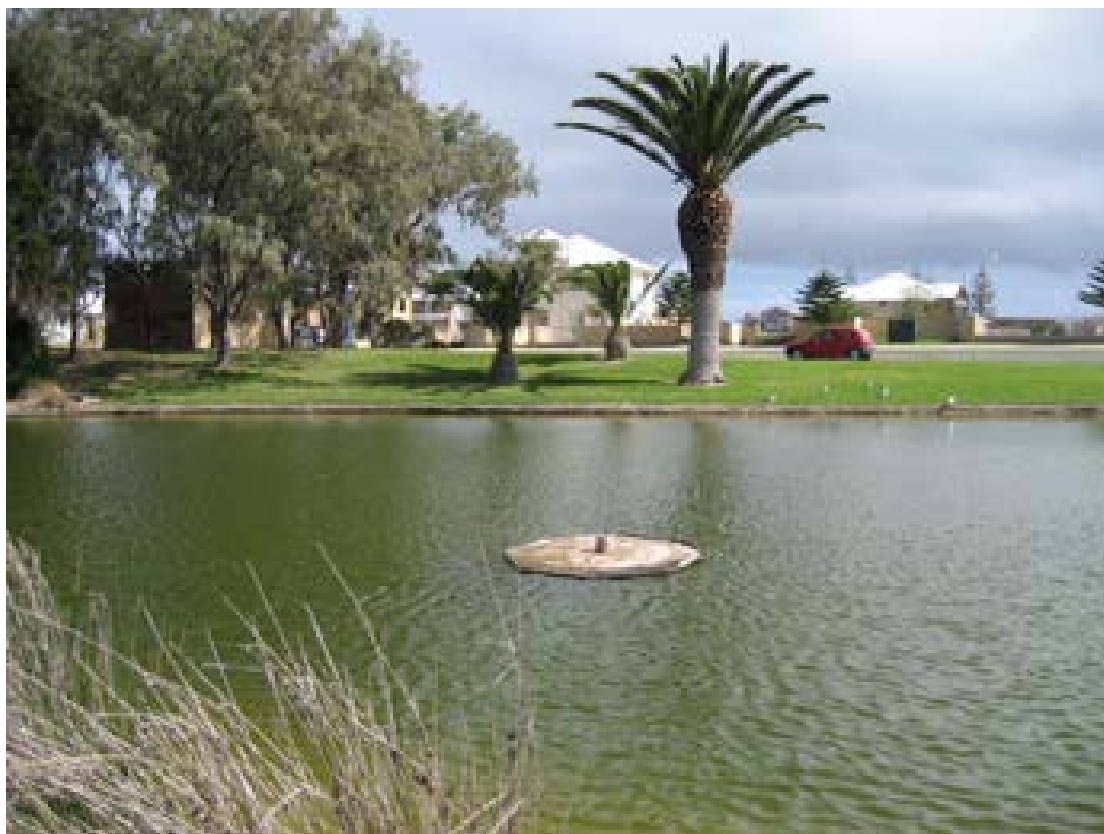
PLATE 3 – Aerator (not operational).

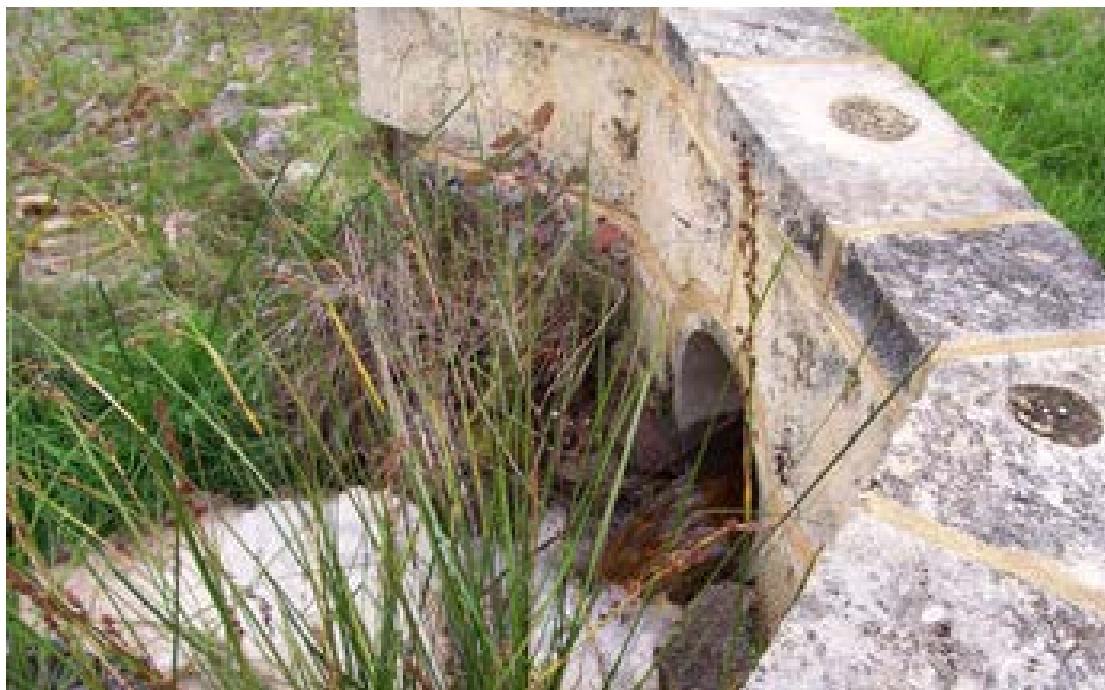
PLATE 1 – Suspected sub-soil drainage flowing into the South Lake.

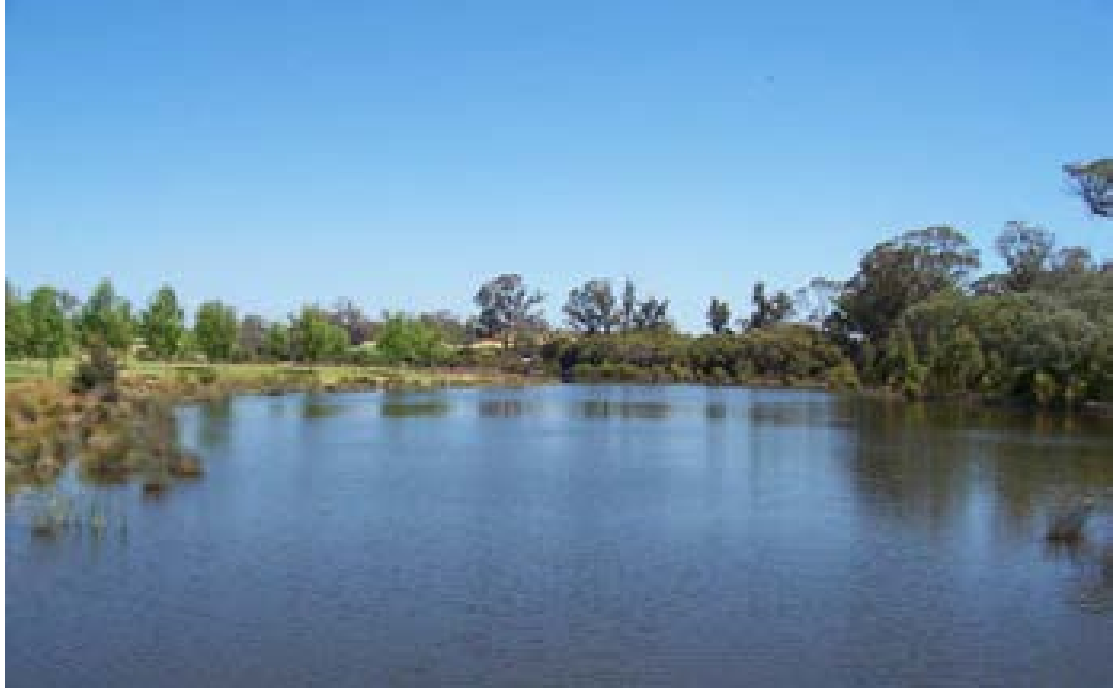
PLATE 1 – View of Central Park North Lake facing north. Park visible to the east and natural remnants of paperbark wetland and tuart forest to the west.

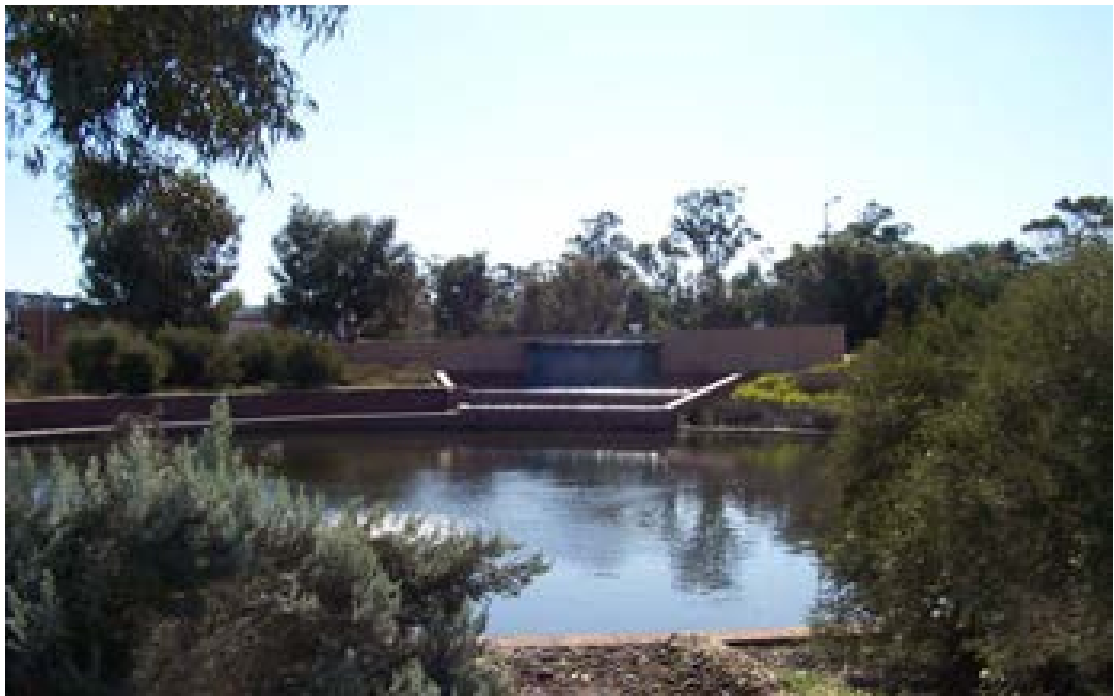
PLATE 2 – Fountain Lake. Overflow from Central Park North Lake overflows via a water fall. The lake also receives drainage via the inlet visible in the foreground.
